Surfside Florida Building Collapse of June 2021 and ACI 318 Building Code Requirements for Structural Concrete

PART 1 OF 4

S. K. Ghosh, S. K. Ghosh Associates LLC

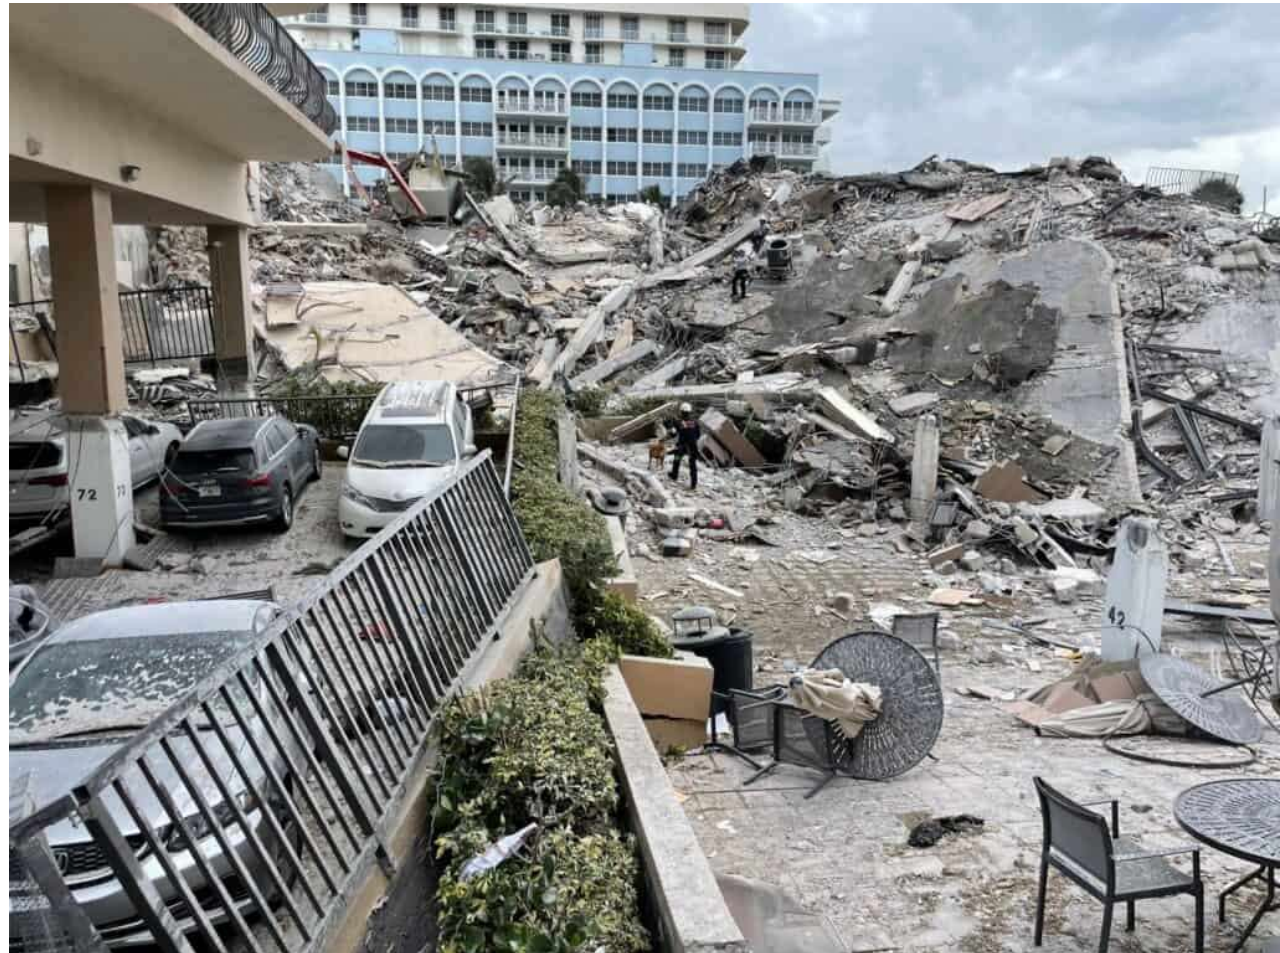
Punching
Shear Failure
of Parking
Structure
Slab

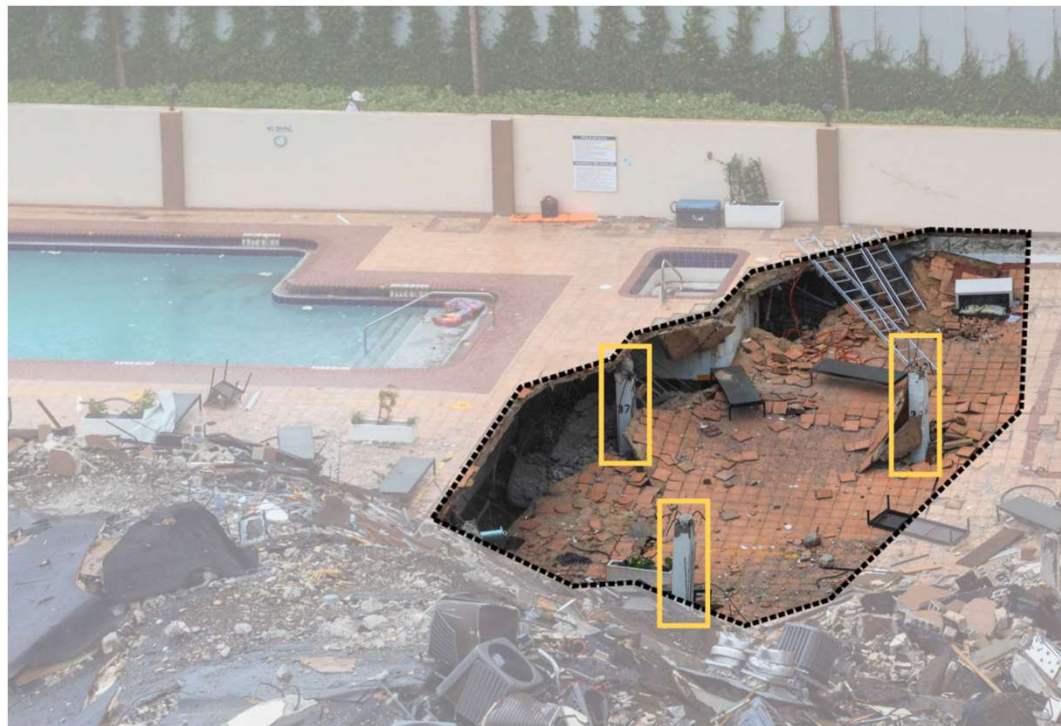
Punching Shear Failure of Parking Structure Slab

The standing columns here suggest the columns “punched through” the deck.

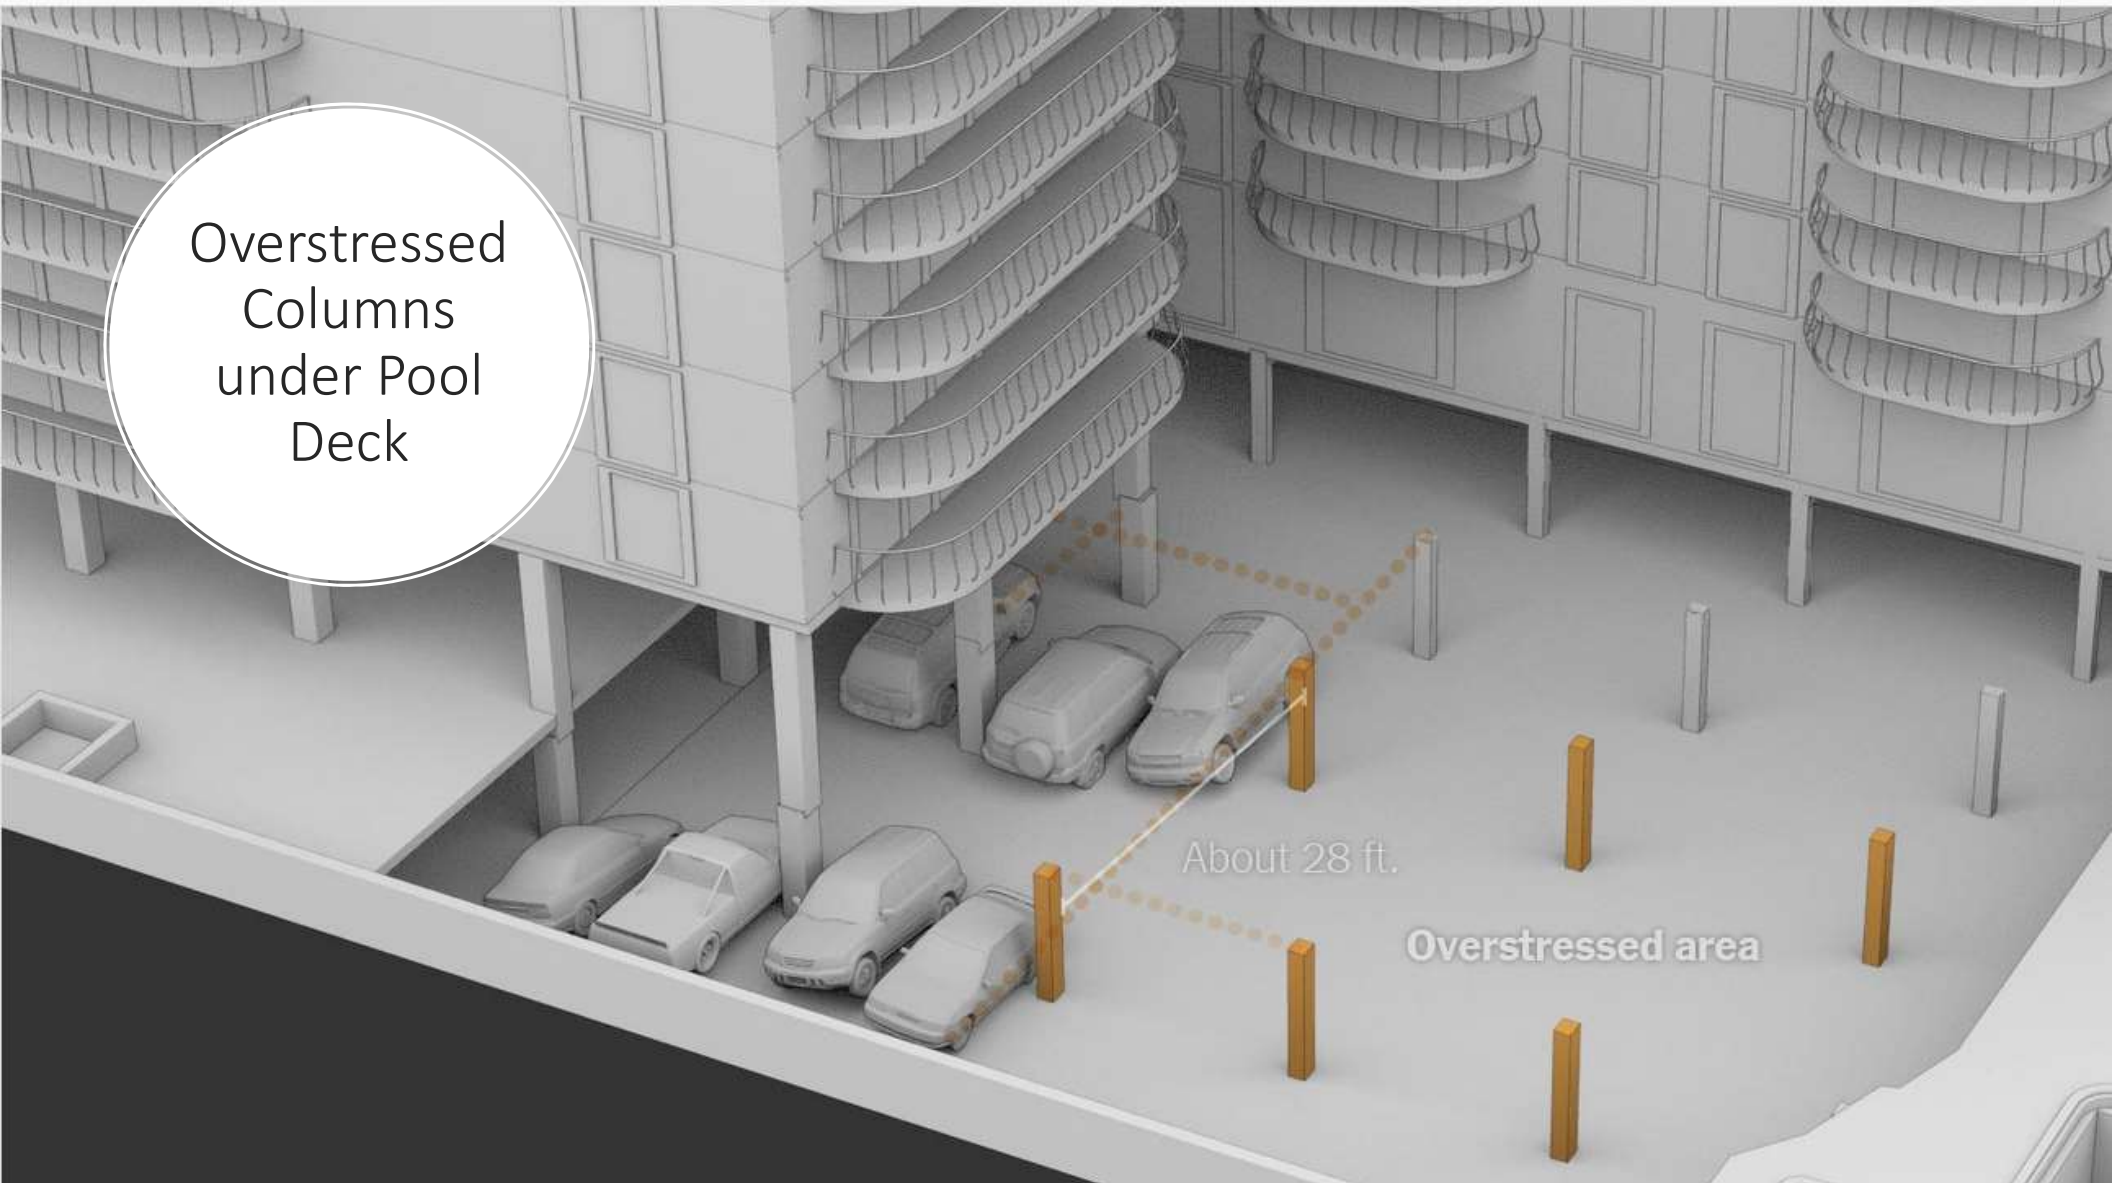
Overstressed
Columns
under Pool
Deck

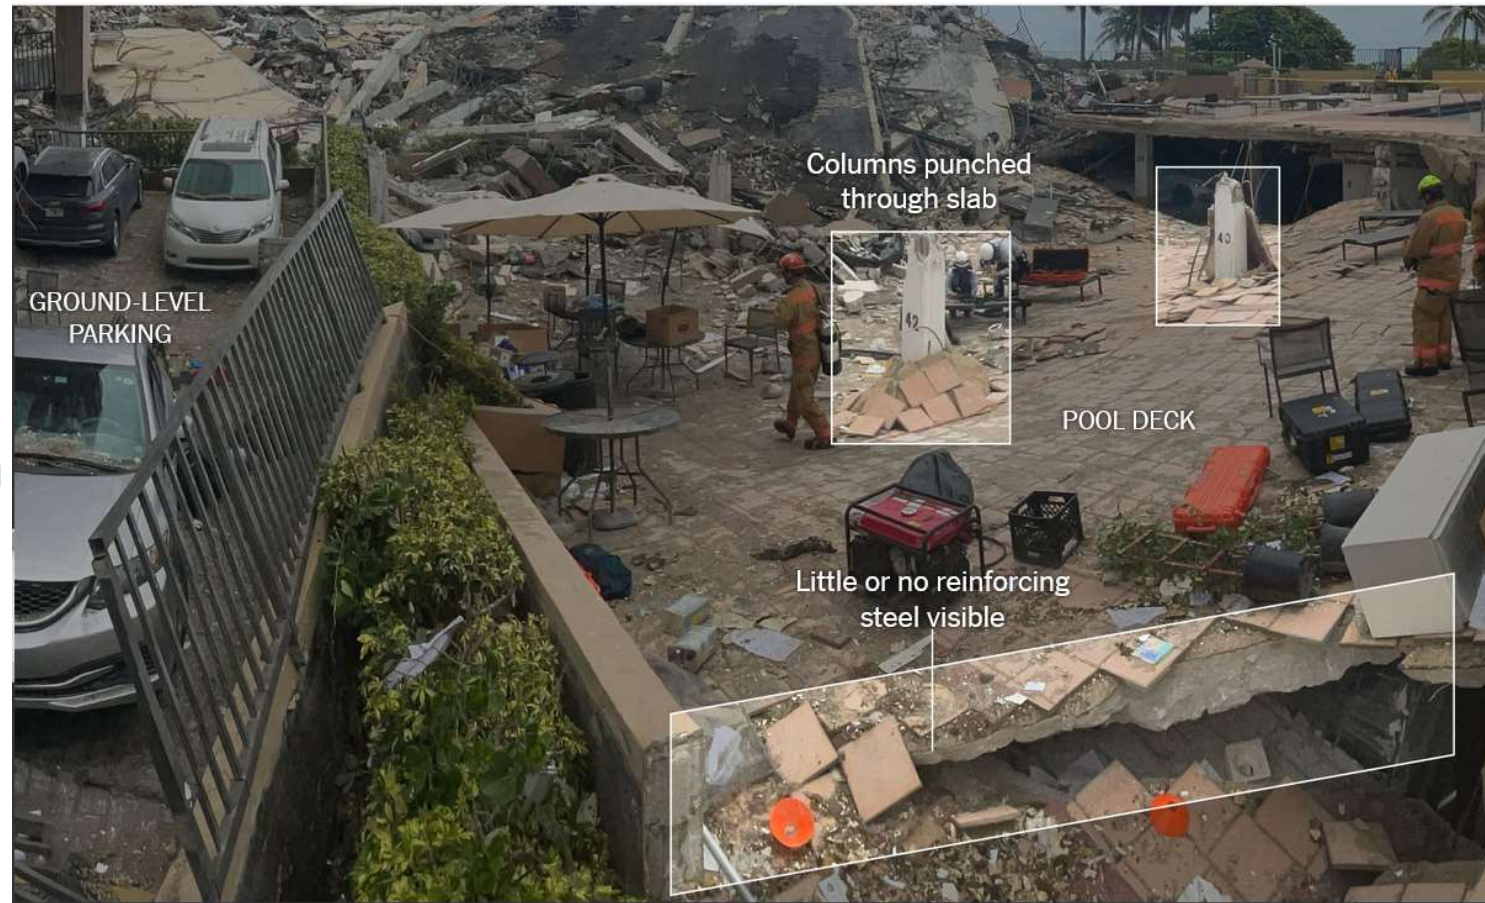
Weak Beams
Supporting
Pool Deck and
“Missing”
Column

Weak beams

Pool Deck Slab Punched through Supporting Columns

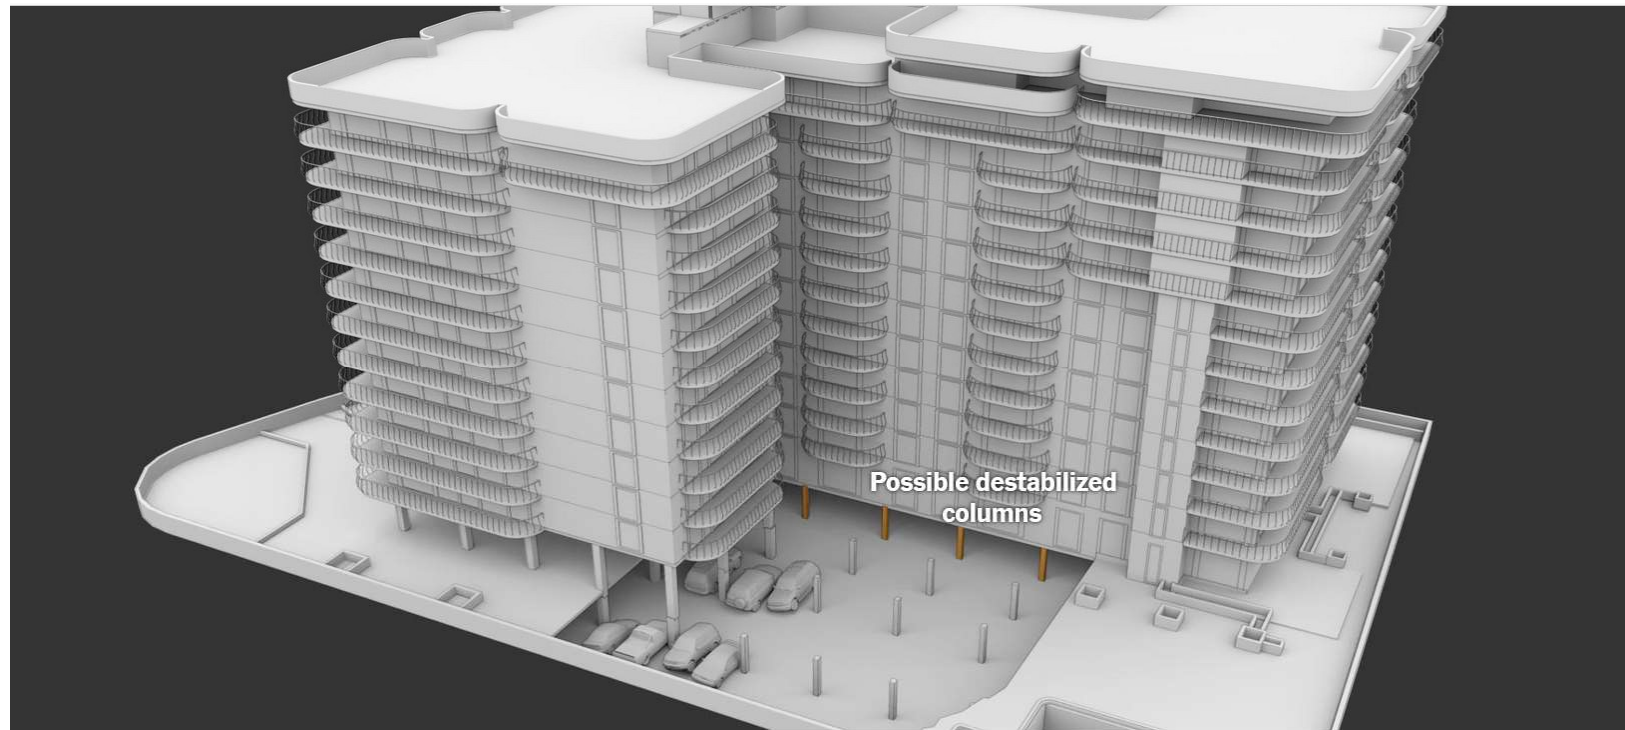
Possible Destabilized Columns Where Partial Collapse Started

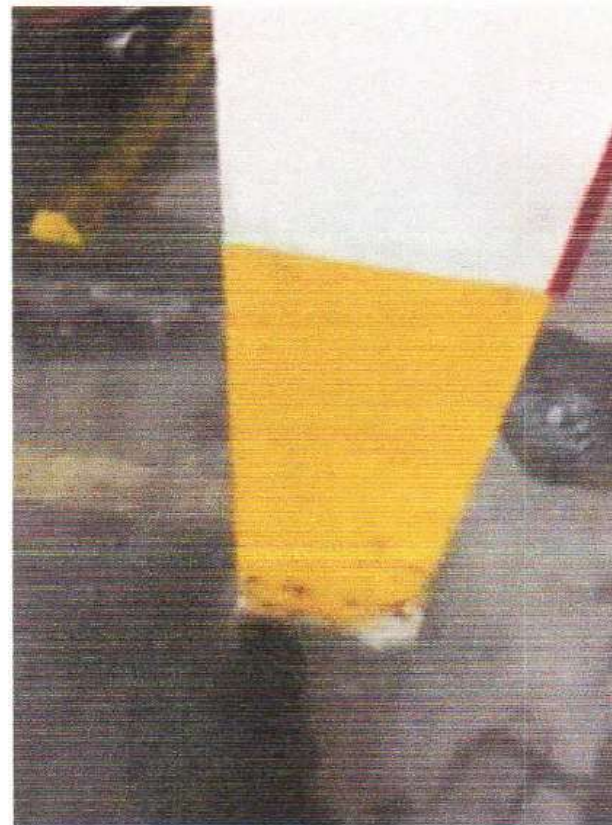
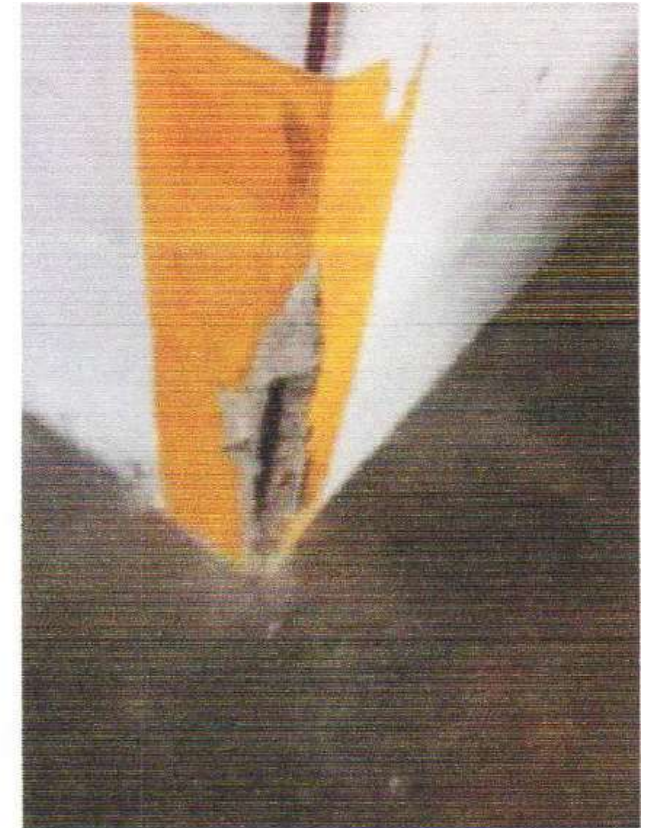
Figure J1: Typical cracking and spalling at parking garage columns

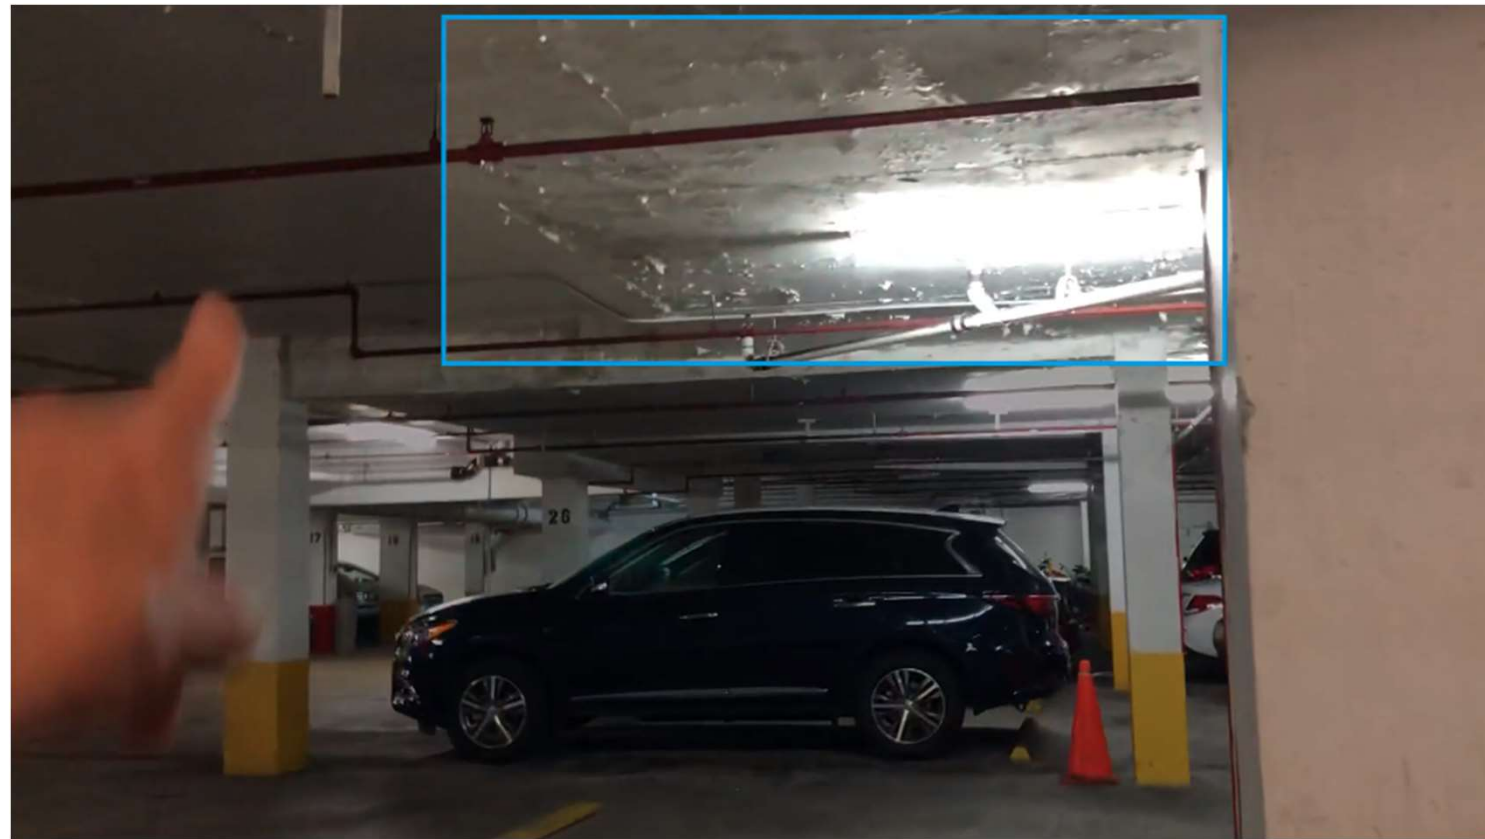
Deterioration
of Parking
Structure Slab
due to Water
Seepage

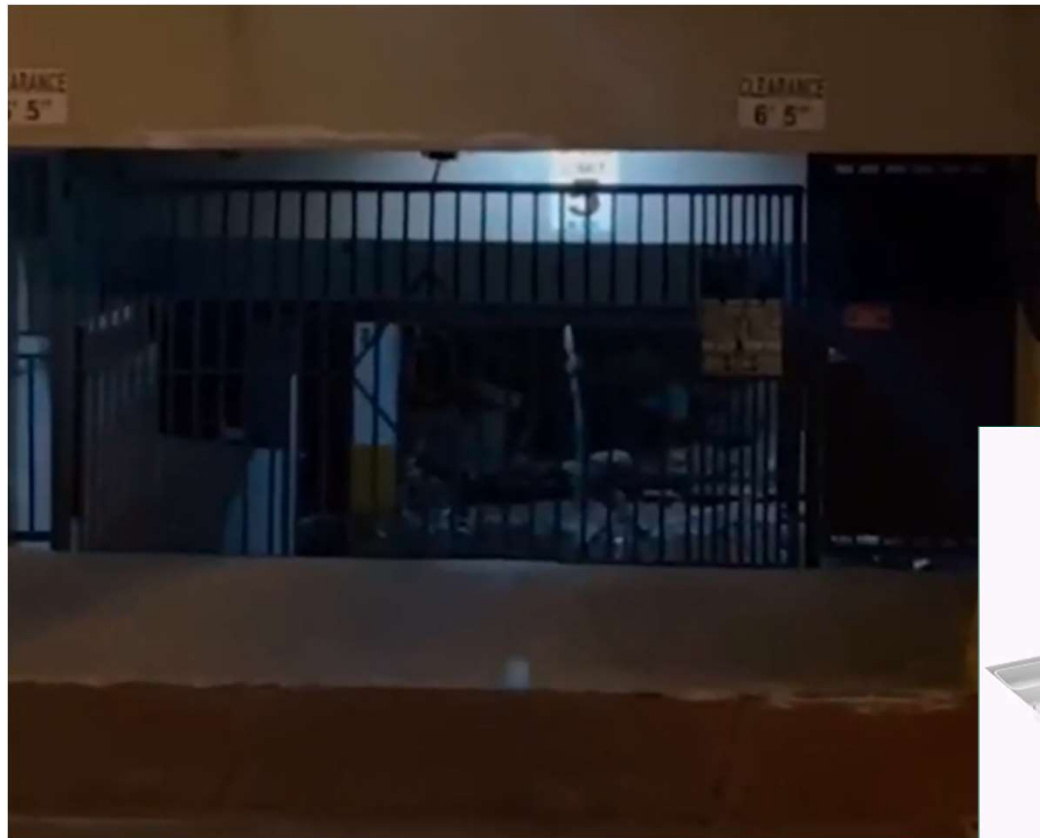
Water Leakage From Ceiling of Garage

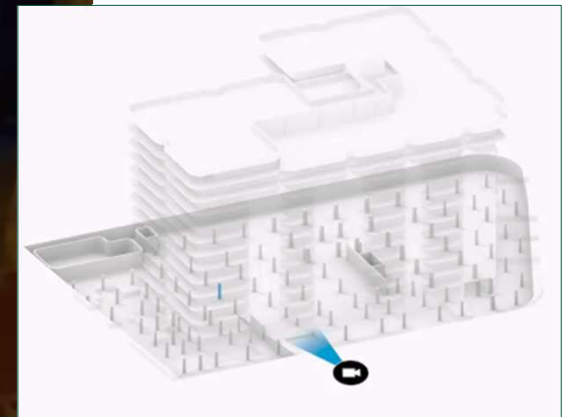
This water leakage was recorded right before the collapse. The water and fallen debris appear to have been roughly below the planter beds on the pool deck's northern edge.
