FIREFIGHTER FATALITY INVESTIGATIVE REPORT

**Sofa Super Store
1807 Savannah Highway
Charleston, South Carolina**

June 18, 2007

**City of Charleston
Post Incident Assessment and Review Team
Phase II Report**

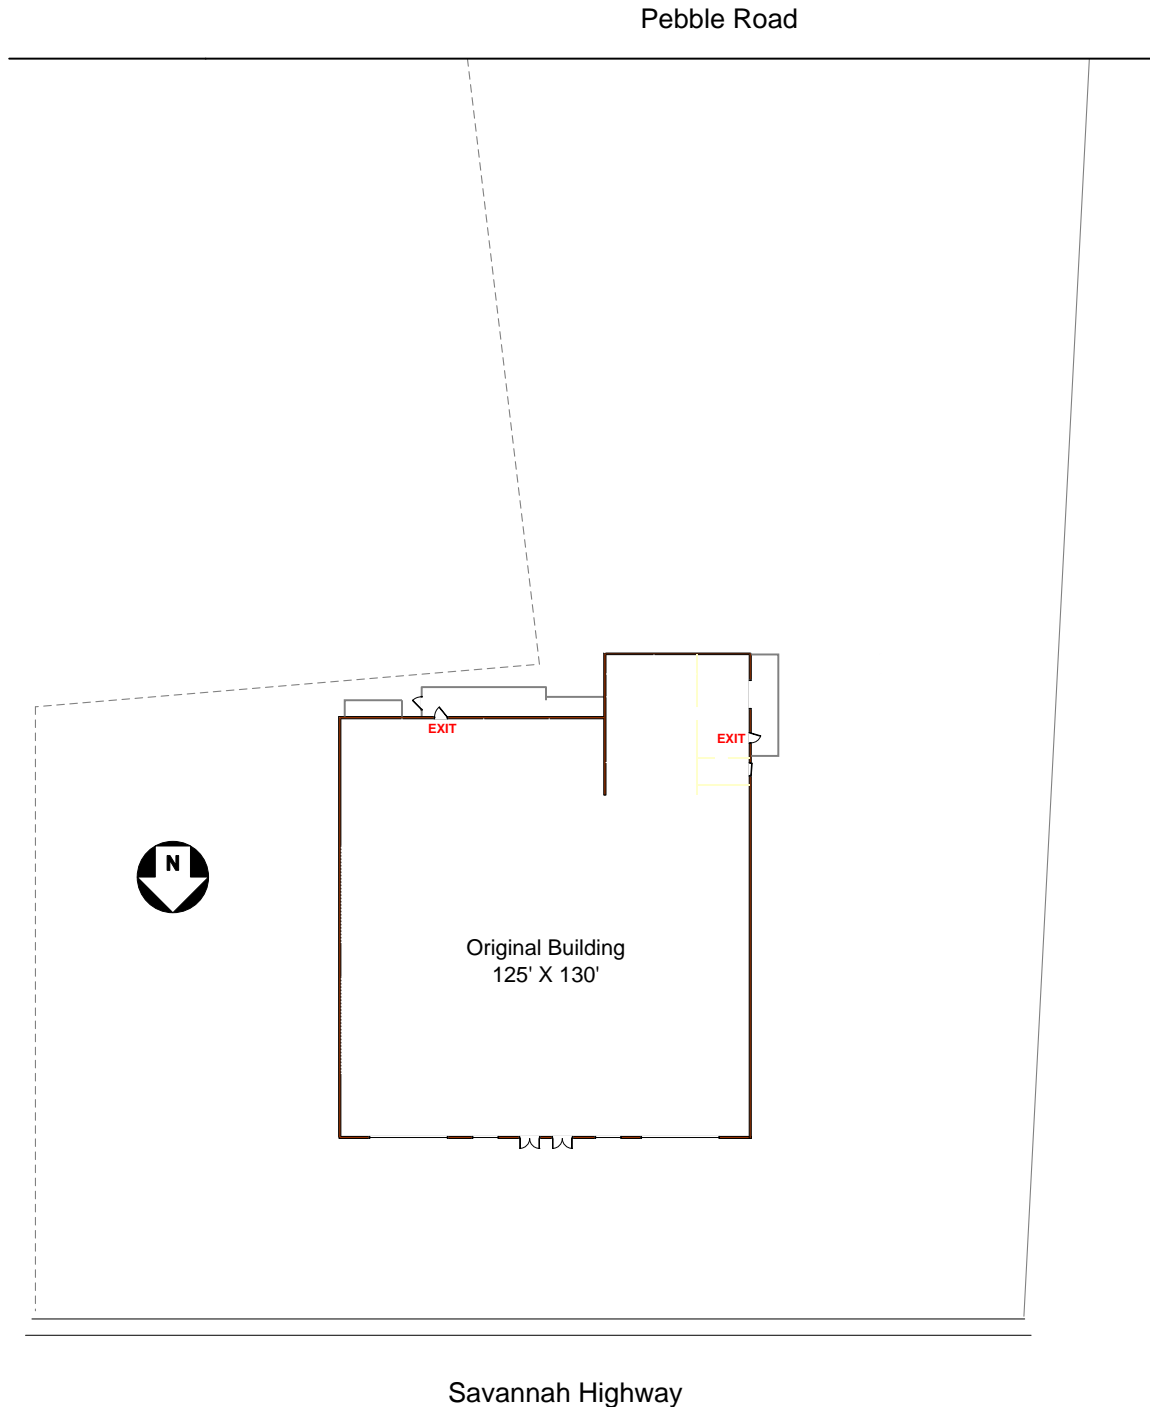
Figure 1: The original grocery store building was constructed in the 1950s or 1960s and annexed into the City of Charleston in 1990.

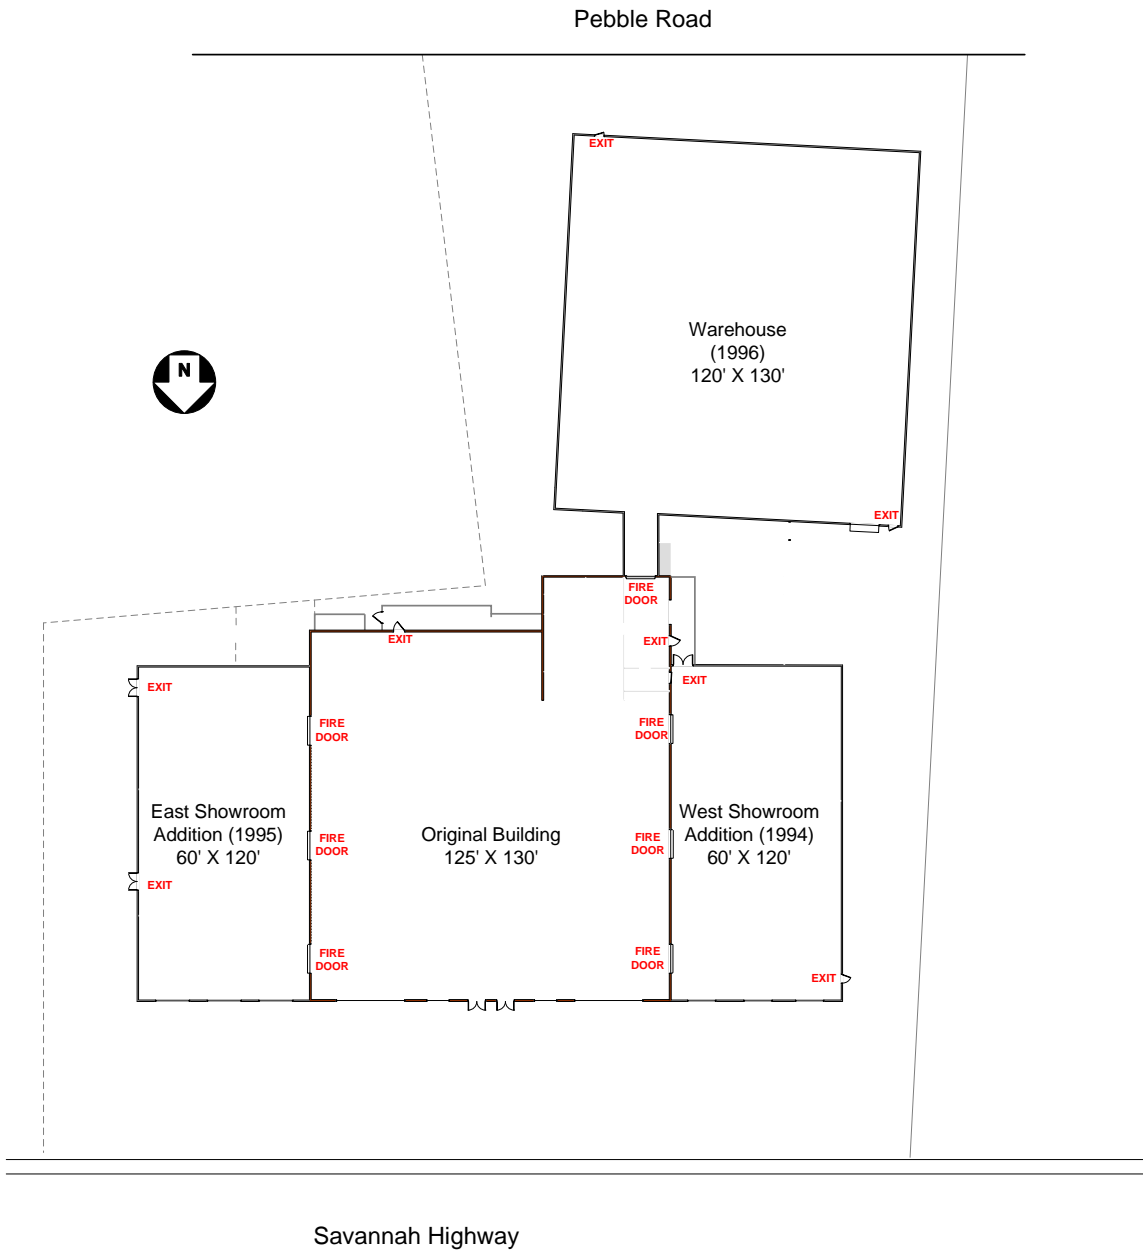
Two building code variances were obtained when the warehouse was constructed. The variances allowed the property owner to omit fire resistance requirements for the north and west walls of the warehouse. The variances were based on physical separation distances from adjacent structures and distances from property lines, as well as an interpretation of the "fire district" definition in the Building Code.

Figure 2: Site plan indicating 4 permitted structures as of 1996. Roll-down fire doors and exits are indicated.

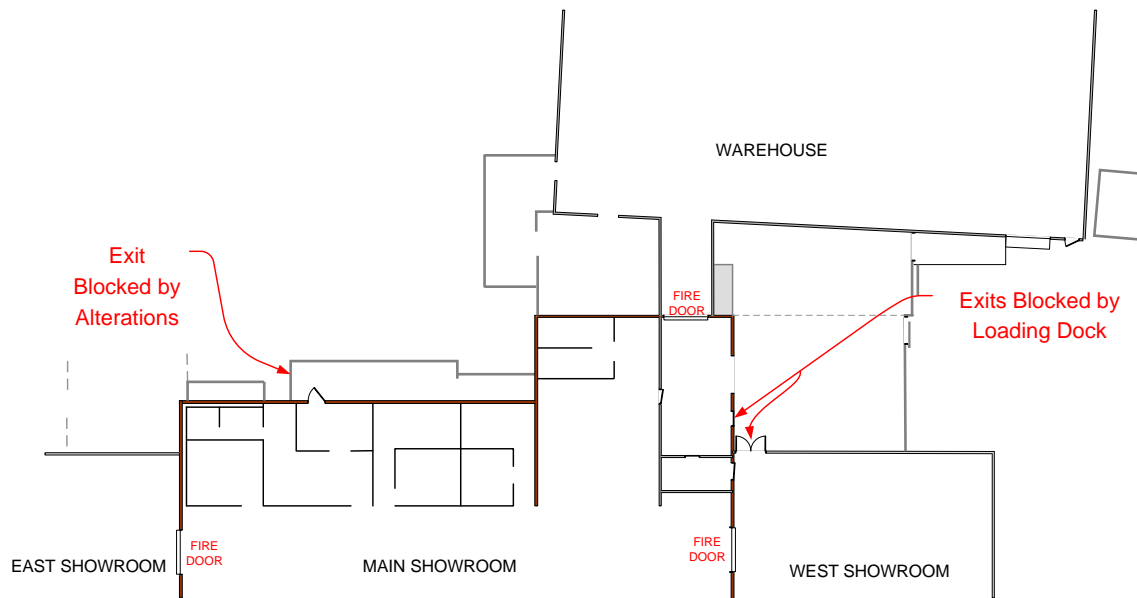
¹ South Carolina OSHA issued citations to the business in reference to the locked exits.

Figure 4: Construction of the loading dock obstructed the egress path from two showroom exits. The construction of offices and modifications to ancillary spaces at the rear of the main showroom obstructed an additional exit.

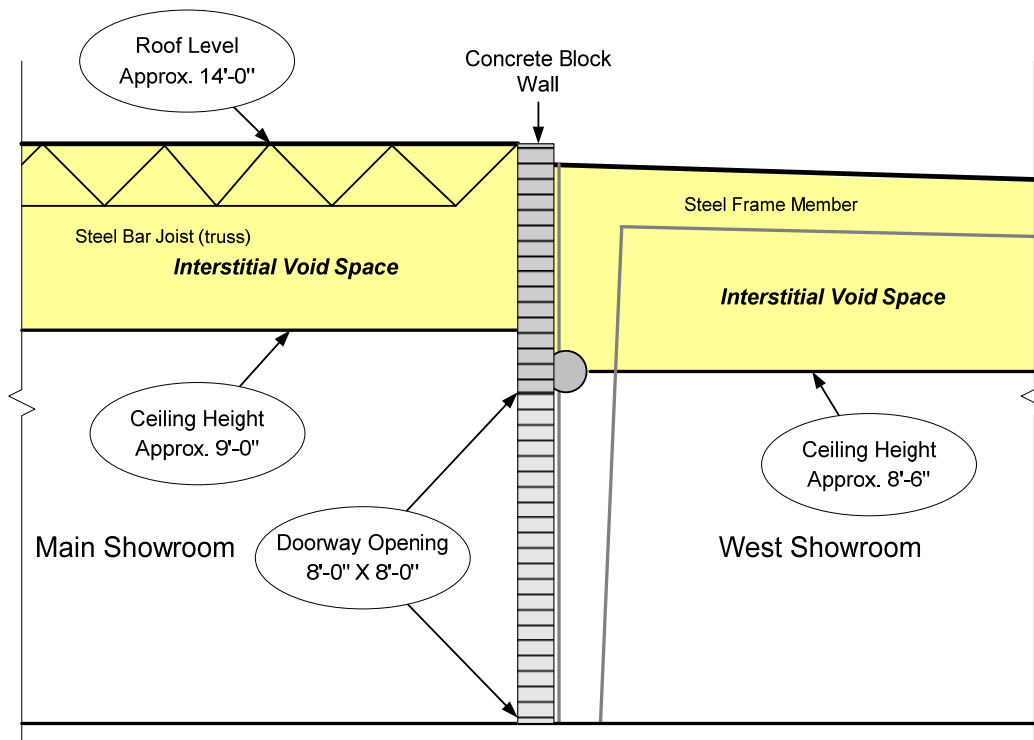
When the void spaces were filled, the smoke would have continued to bank down into the showrooms where the firefighters were working. The smoke would have quickly obscured their visibility and the temperature would have gradually increased as the hot gases stratified at the ceiling level and descended toward the floor. This would produce the same type of fuel-rich atmosphere within the showrooms as above the ceilings, setting the stage for the contents of the store to become involved in a rapidly spreading fire.

Figure 5: Cross section through the concrete block wall, separating the middle showroom from the west showroom. The interstitial void spaces above the ceilings in both areas are indicated.

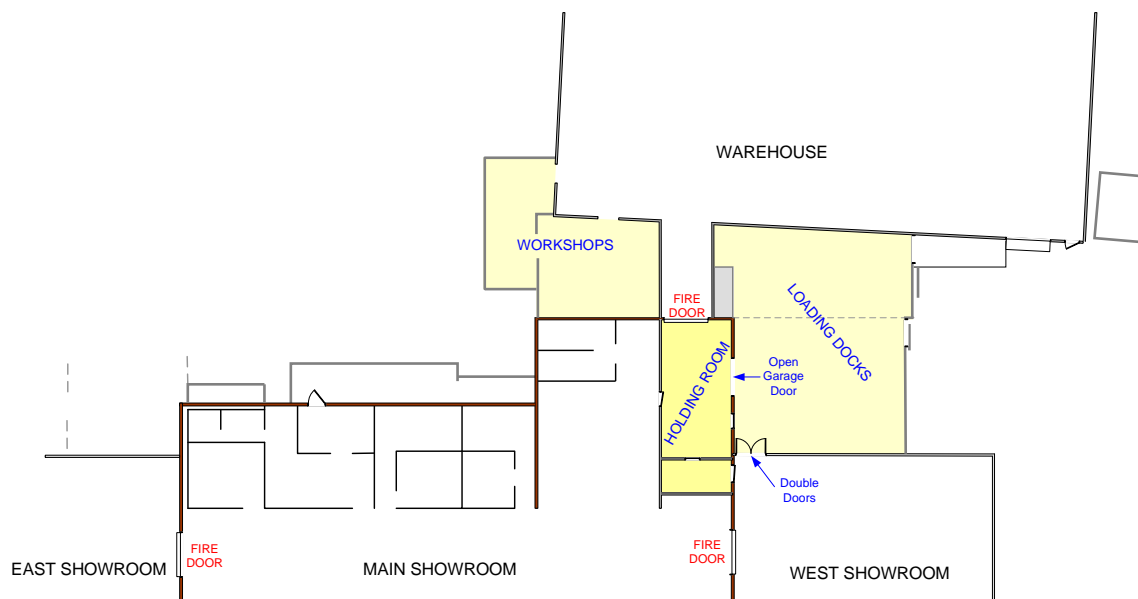
There was no ceiling above the holding room – the steel bar joists that supported the roof were exposed. The heat, smoke and fire gases that were produced by the fire in the loading dock flowed into the holding room and had direct access to the interstitial void space above the main showroom.

Figure 6: The holding room was located within the walls of the original building. An open garage door provided a direct path for the fire to spread from the loading dock into the holding room.

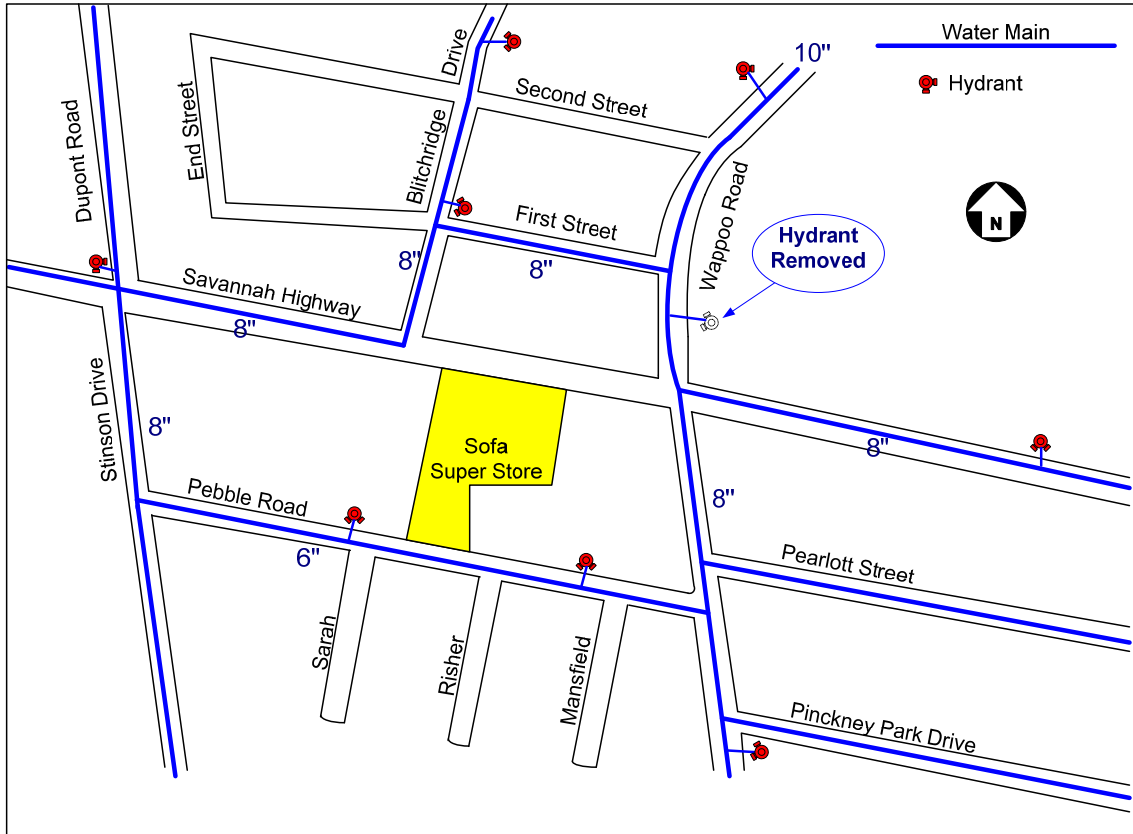
⁶ The hydrant had been removed because it was in a location where it was frequently struck and damaged by trucks entering the adjacent property.

Figure 7: Fire hydrants and water mains in proximity to the fire scene.

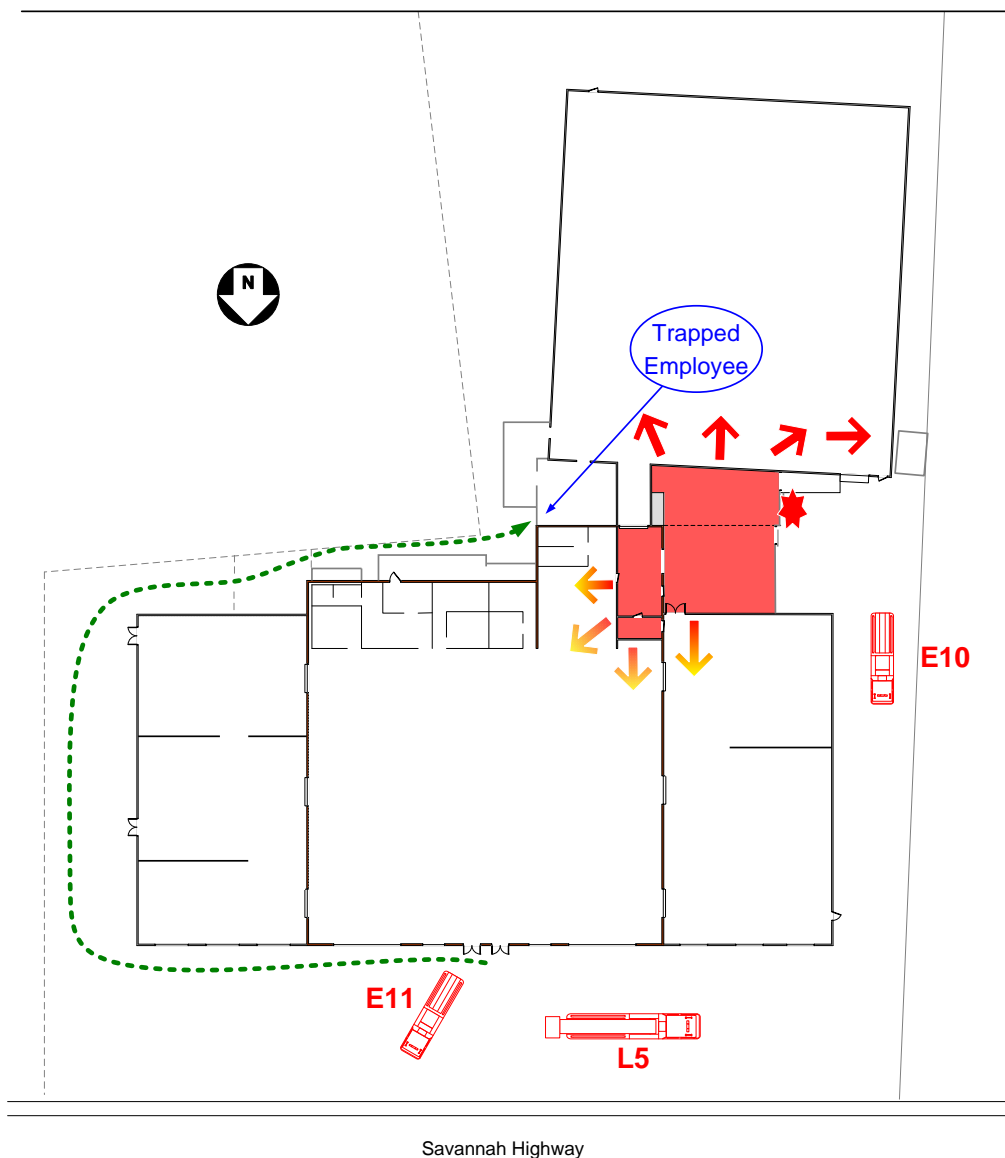
Figure 13: The employee was trapped in a workshop room that was located between the warehouse and the main showroom. The rescue team came from the front of the showroom building, around the east end to the rear, and cut through the metal wall to rescue him.

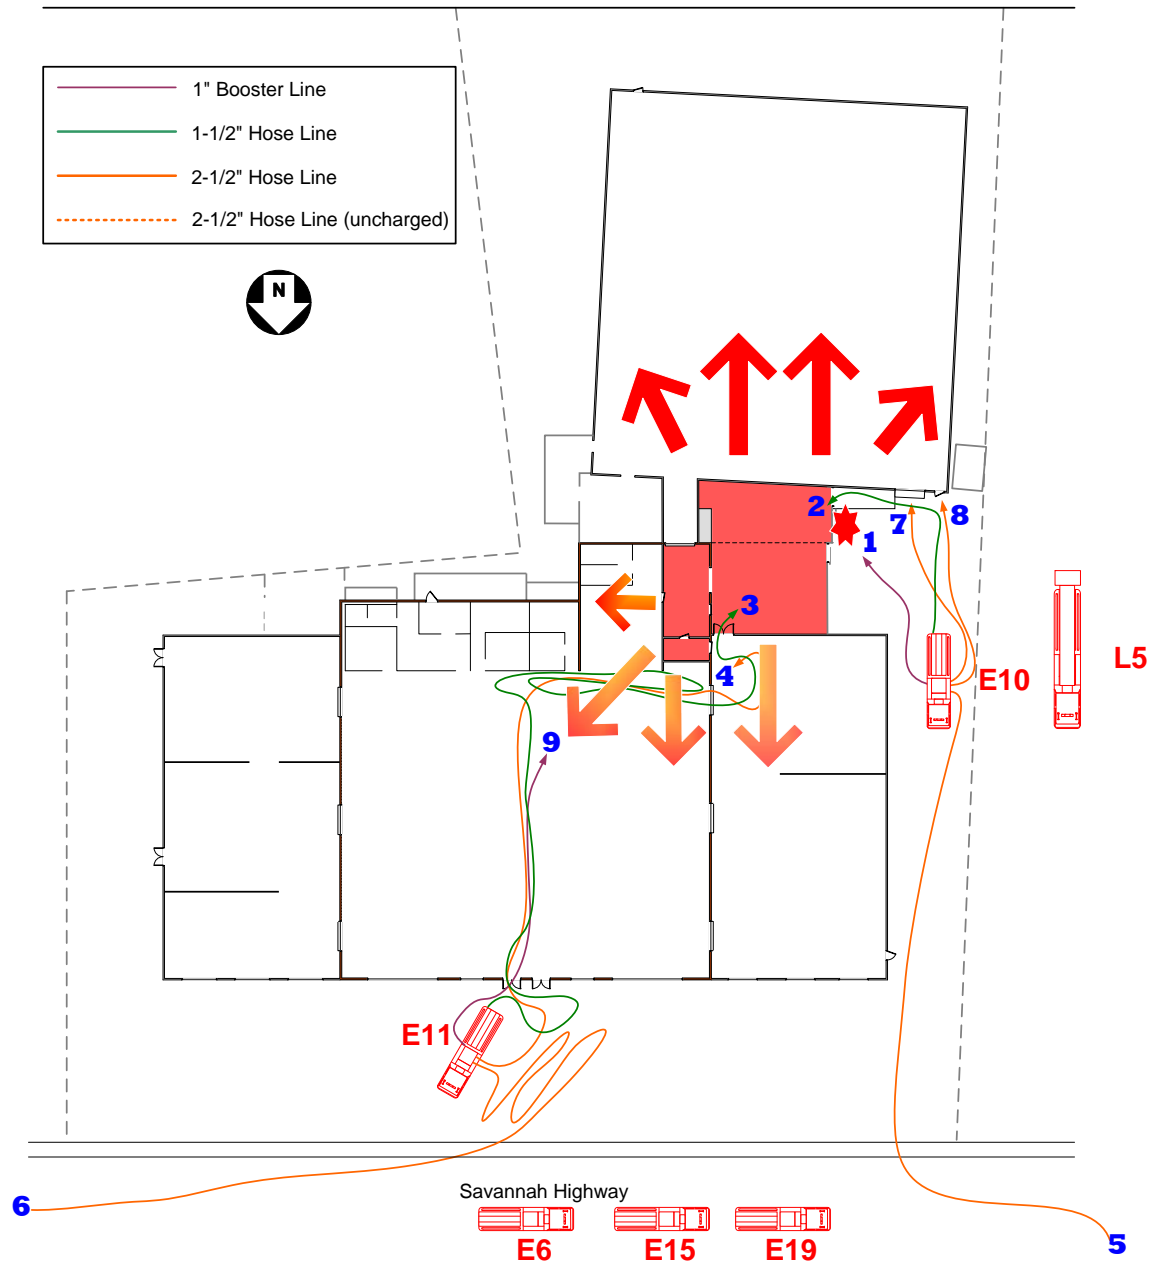
Figure 14: Conditions in the rear of the showrooms changed quickly, causing the firefighters to abandon their hose lines and attempt to find their way out of the building. The fire was extending from north to south inside the warehouse at the same time. (Approximate time 19:28 – 19:29)

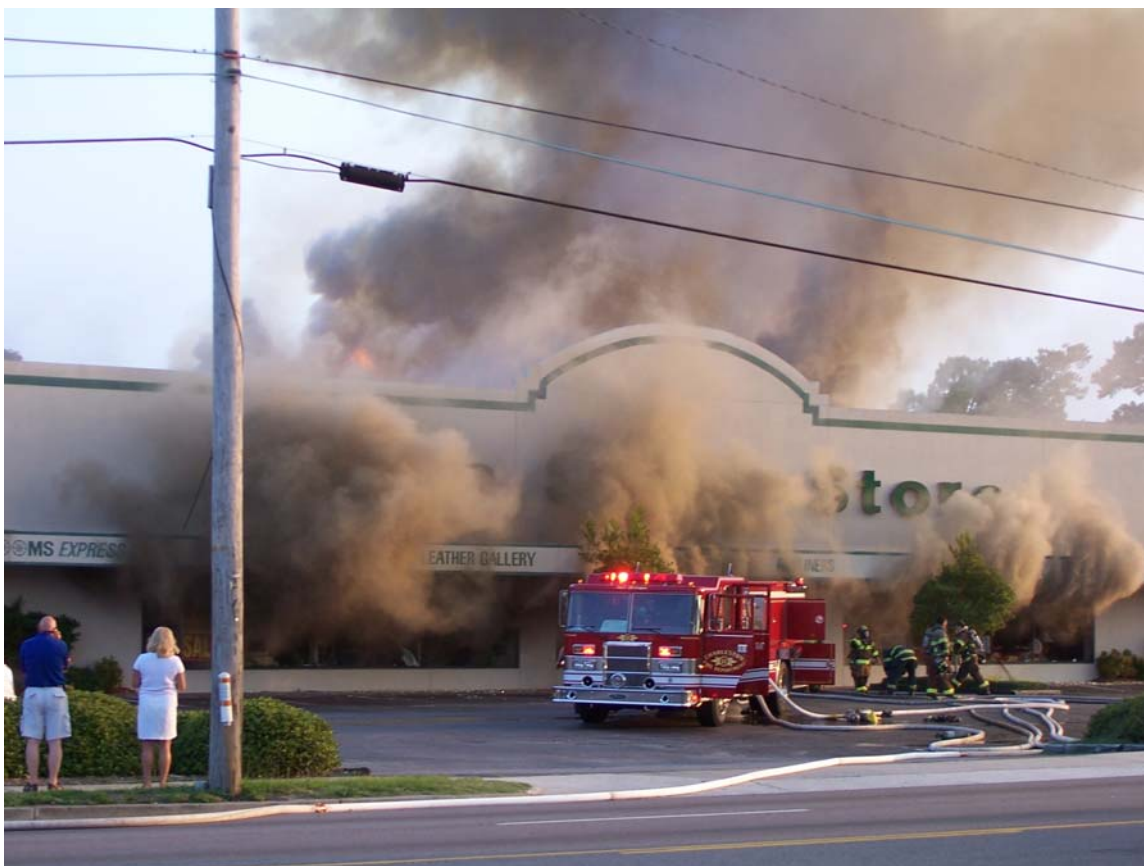
Photo 7: Smoke begins to flow from the broken windows on both sides of the store entrance. This photograph was taken at 19:36:05. (Photo courtesy of Stewart English)

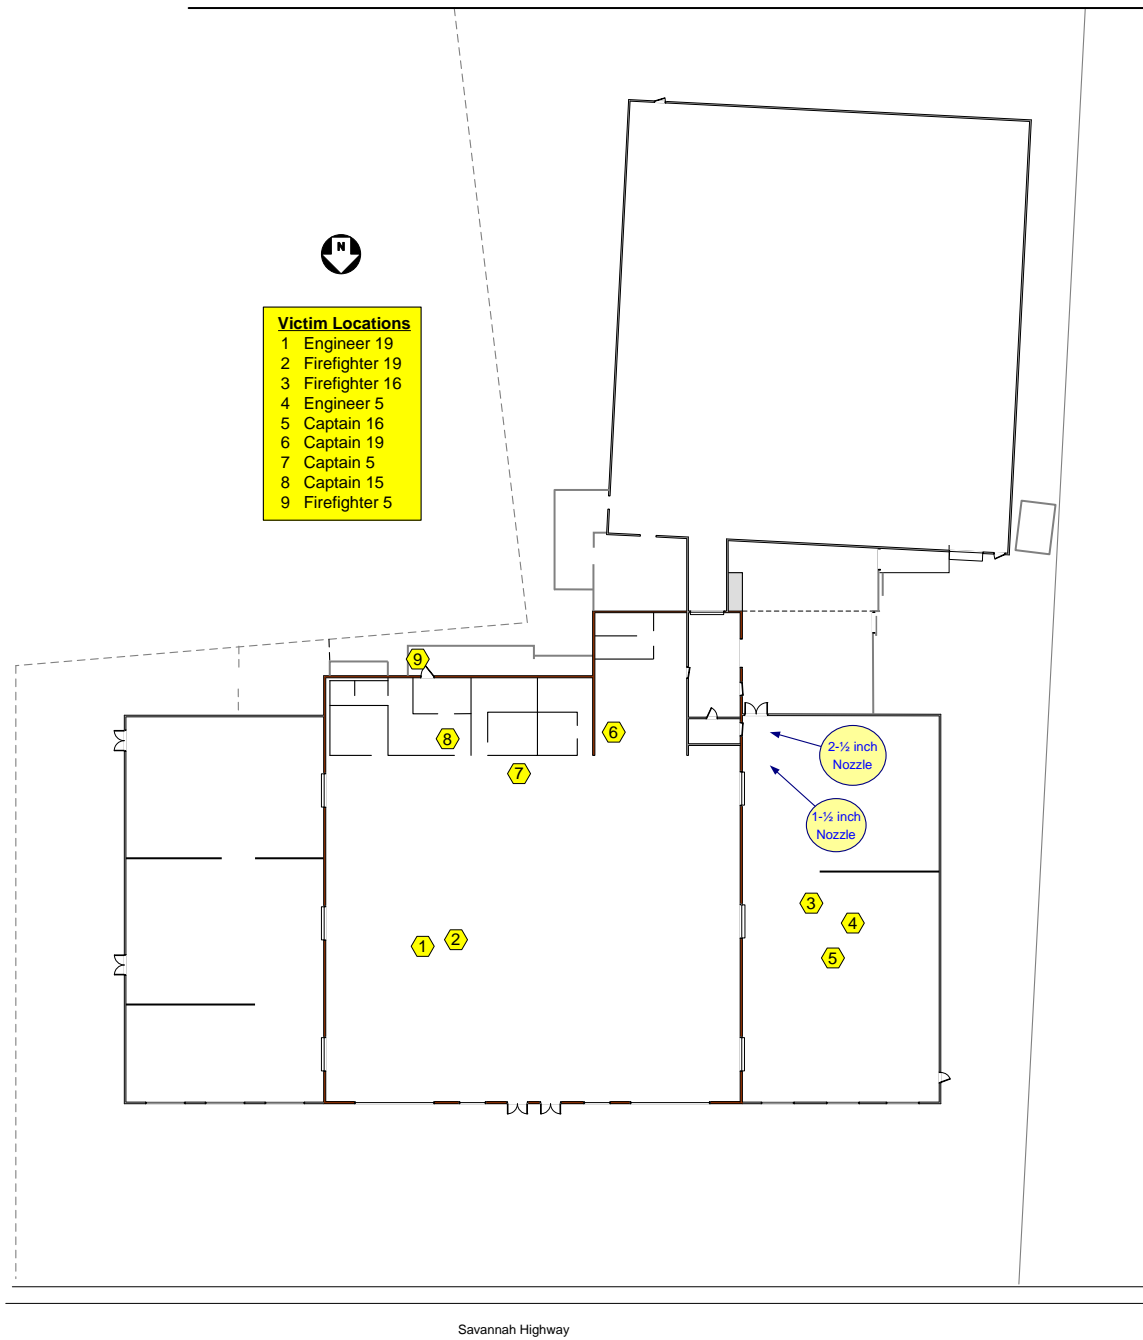
The evidence indicates that the structural collapse of the roof occurred after the firefighters were incapacitated or deceased. The roof of the main showroom did not collapse until almost 20 minutes after the interior became fully involved in fire. The roof collapse did not cause their deaths.

Figure 15: Locations of the deceased firefighters as recorded by the Charleston County Coroner.

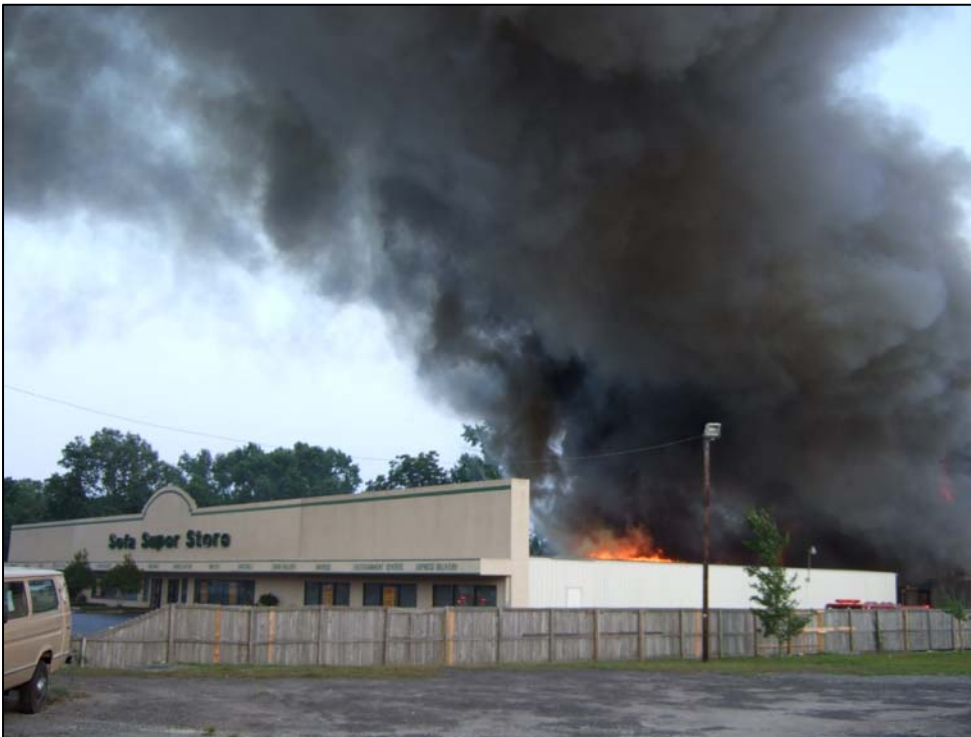
Photo 11: Fire Visible from the roof of the retail area. This photo was taken at 19:24:07. (Photo courtesy of Dan Folk)

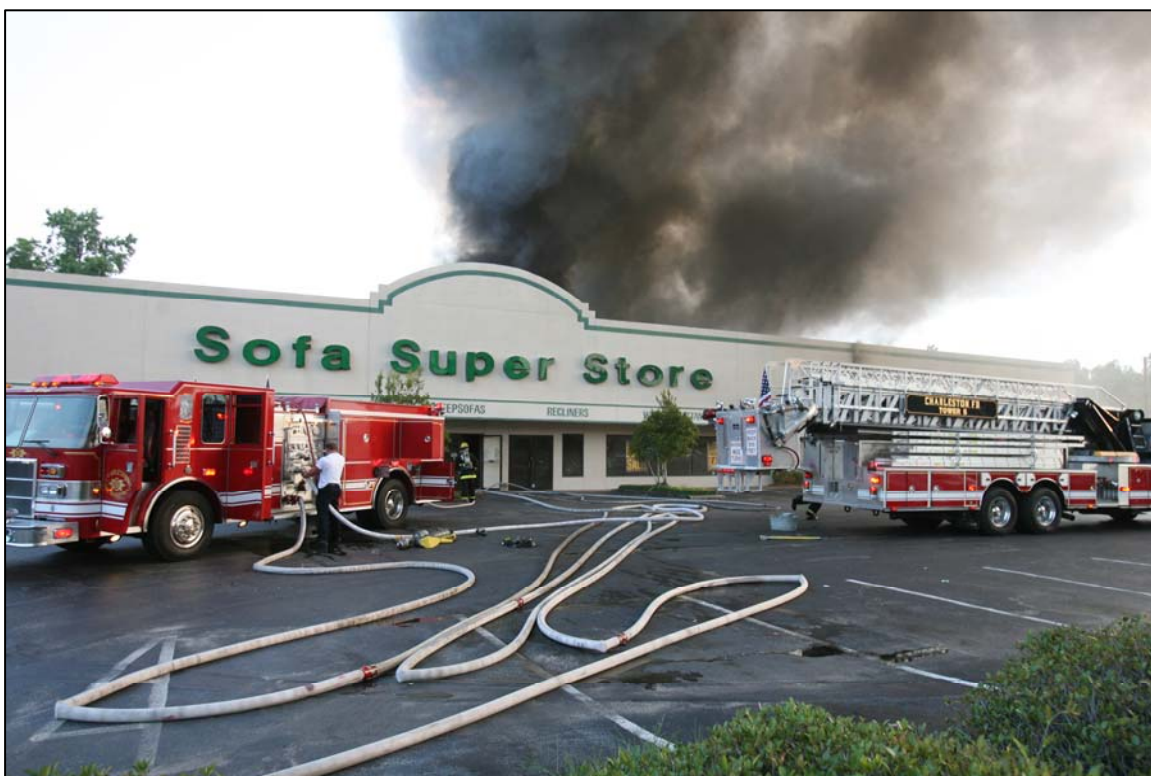
Photo 12: The scene at the front of the store at 19:31:23. Note the lack of pressure evidenced by the kinks in the supply line feeding Engine 11. (Photo courtesy Charleston Post and Courier)
