StEER: Structural Engineering Extreme Event
Reconnaissance Network
HURRICANE FLORENCE: FIELD ASSESSMENT TEAM 1 (FAT-1)
EARLY ACCESS RECONNAISSANCE REPORT (EARR)

(UAV selfie courtesy of Blake Lytle)

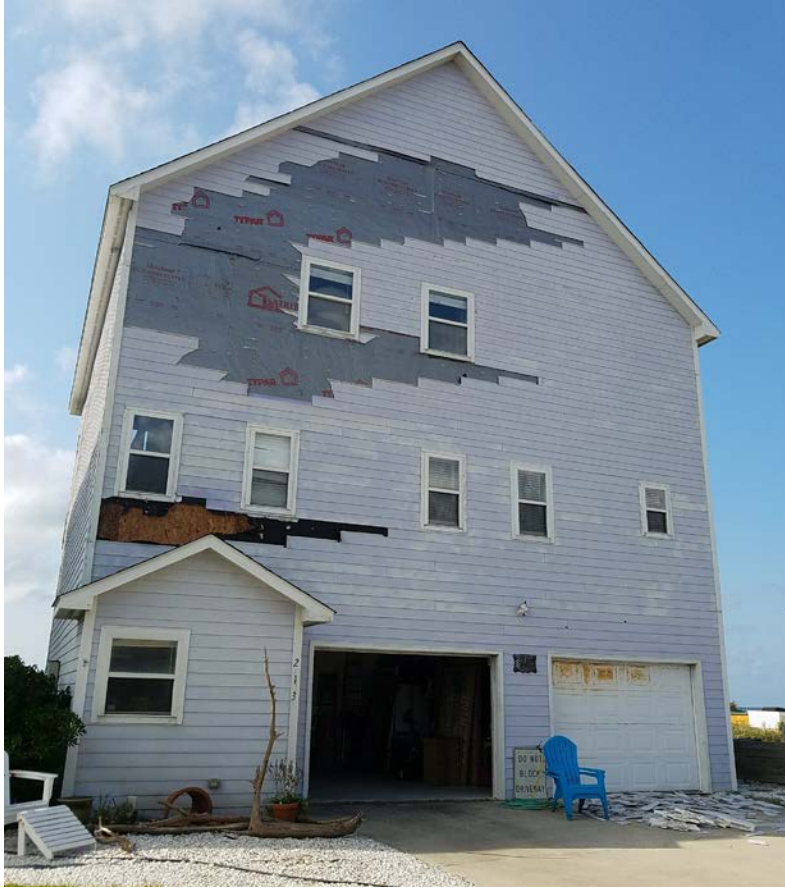
Figure 8: Loss of wall cover at residence in Atlantic Beach

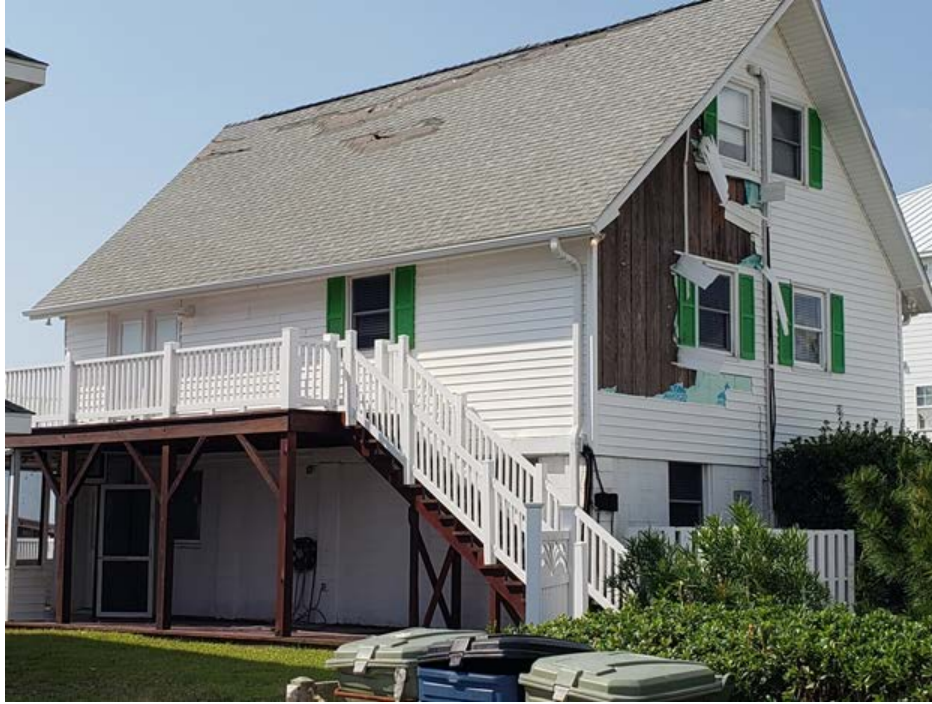
Figure 9: Loss vinyl siding installed over wood panel siding and shingle loss near roof ridge in Emerald Isle

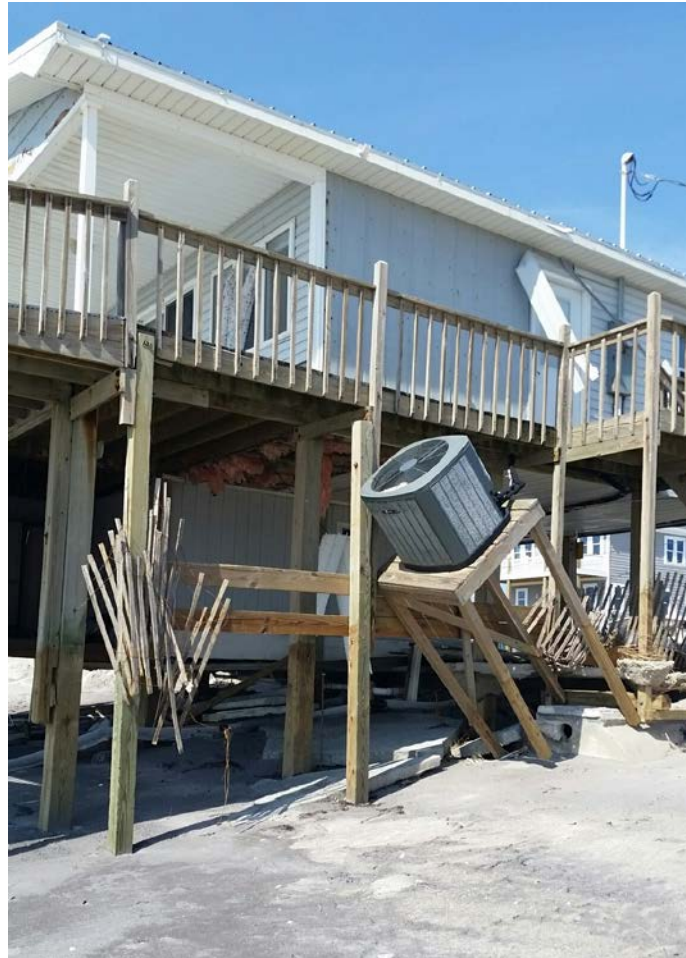
Figure 10: Property in North Topsail Beach with erosion and surge-induced property damage, note loss of vinyl siding though soffits and metal roof performed well.

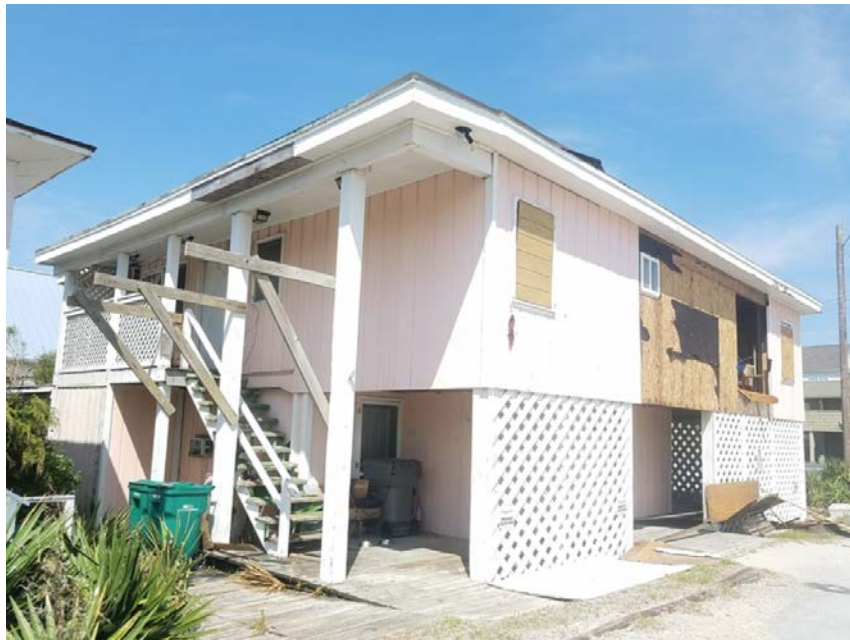
Figure 11: Loss of wood panel siding in Surf City

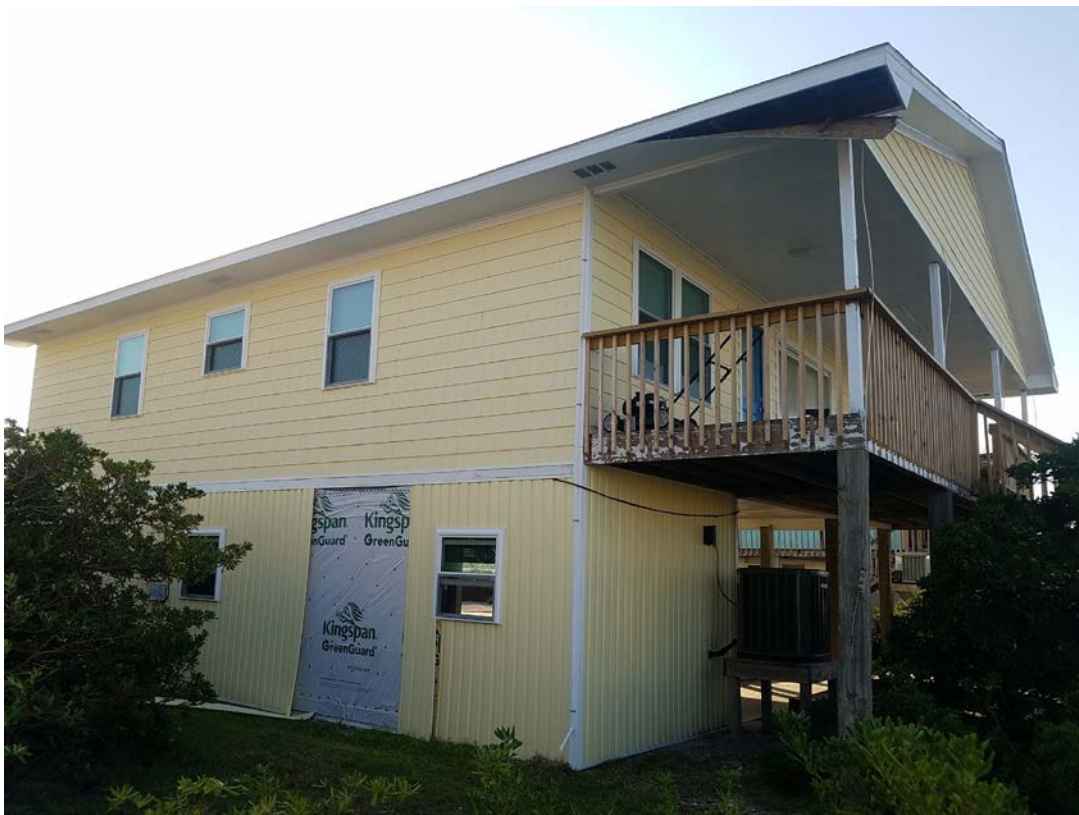
Figure 12: Damaged residence in Topsail Beach with siding loss and soffit damage

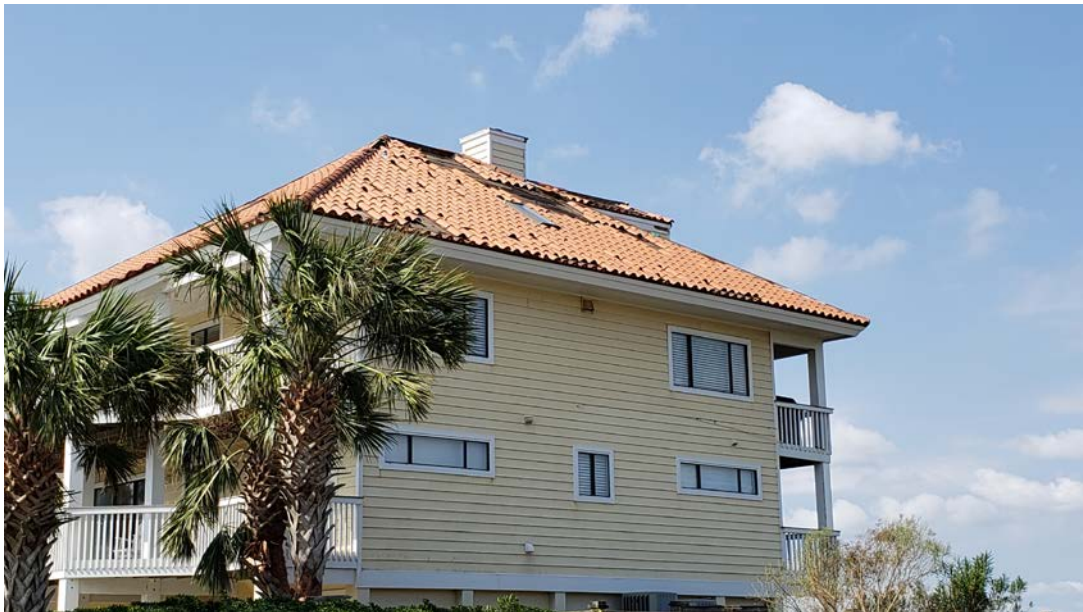
Figure 13: Damage to tile roof in Wrightsville Beach

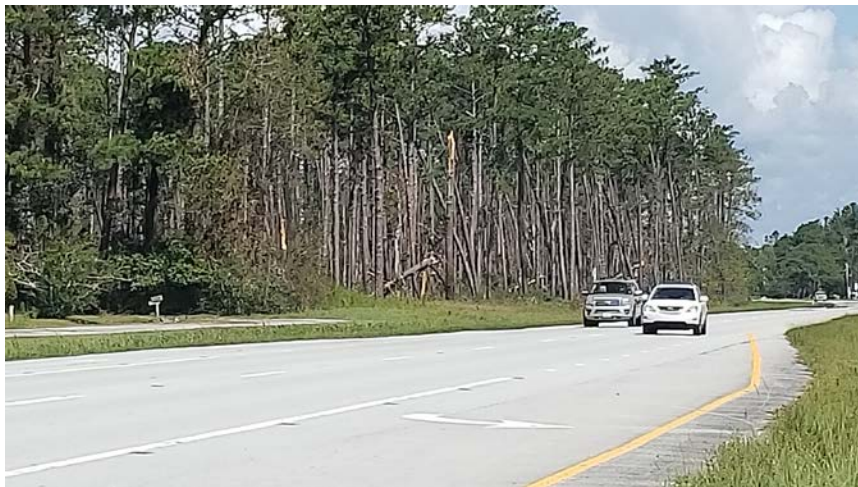
Figure 15: Snapped pine trees along US 70 between Havelock and New Bern
