Innovative Regulatory Practices in Low and Middle-Income Countries

The Building Regulations Program at the World Bank

Rapid & Reliable Building Assessment

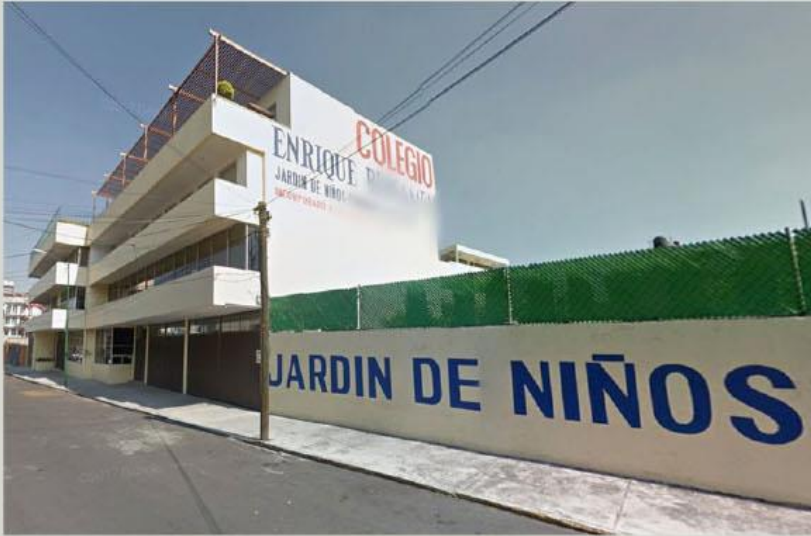
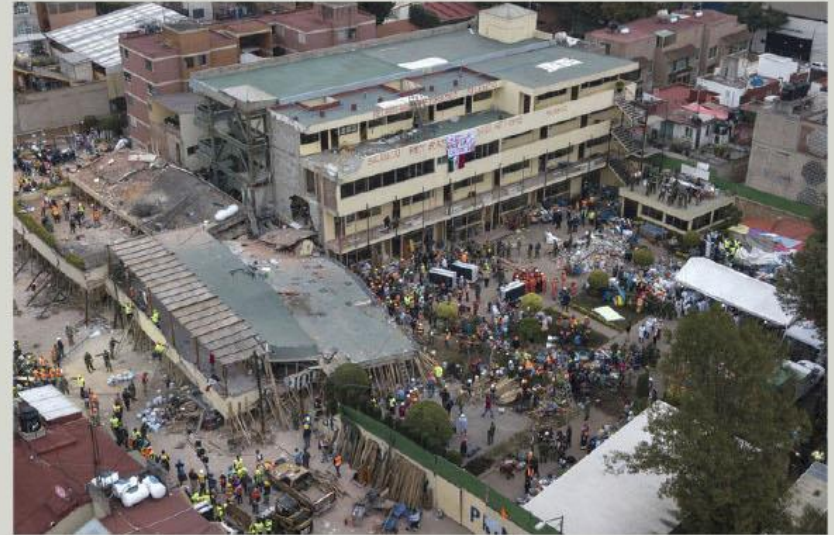
SOFT-STORY BUILDINGS

School in Mexico City

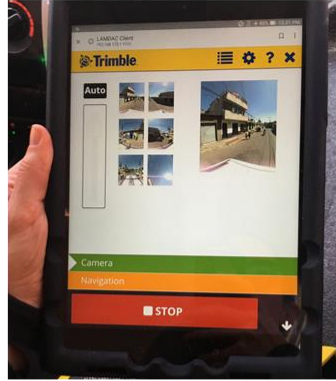
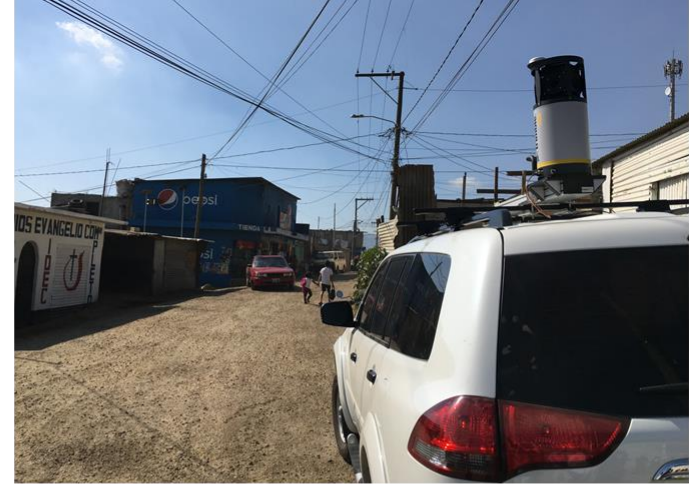
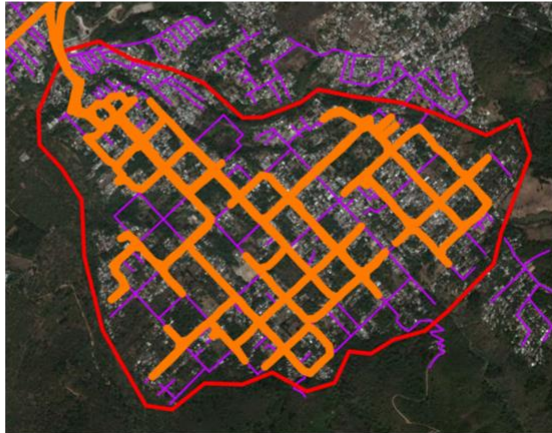
Streetview

- Collected using a Trimble MX7 360 camera mounted on top of an SUV
- Uploaded to Mapillary platform for 'tagging'

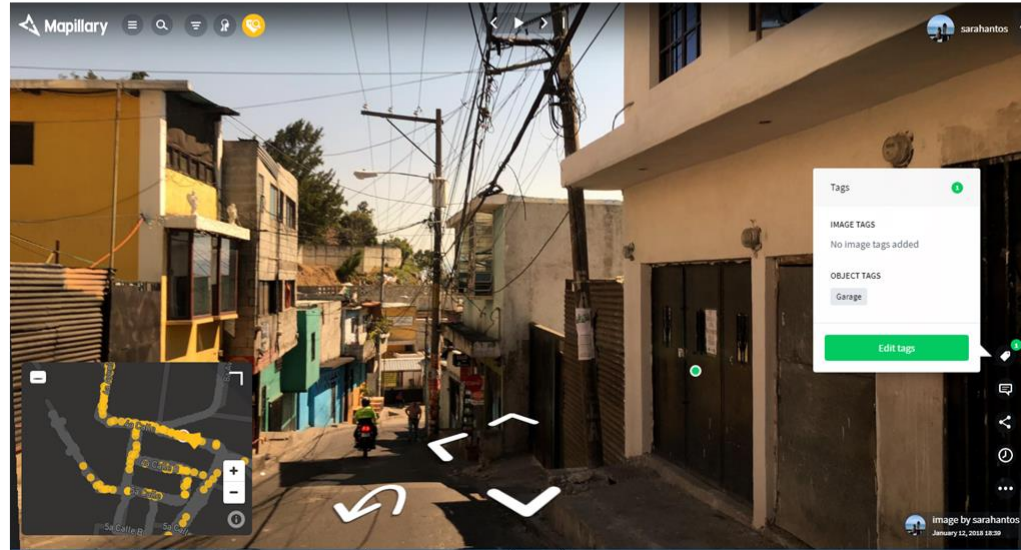
Orange = Streets driven in El Porvenir

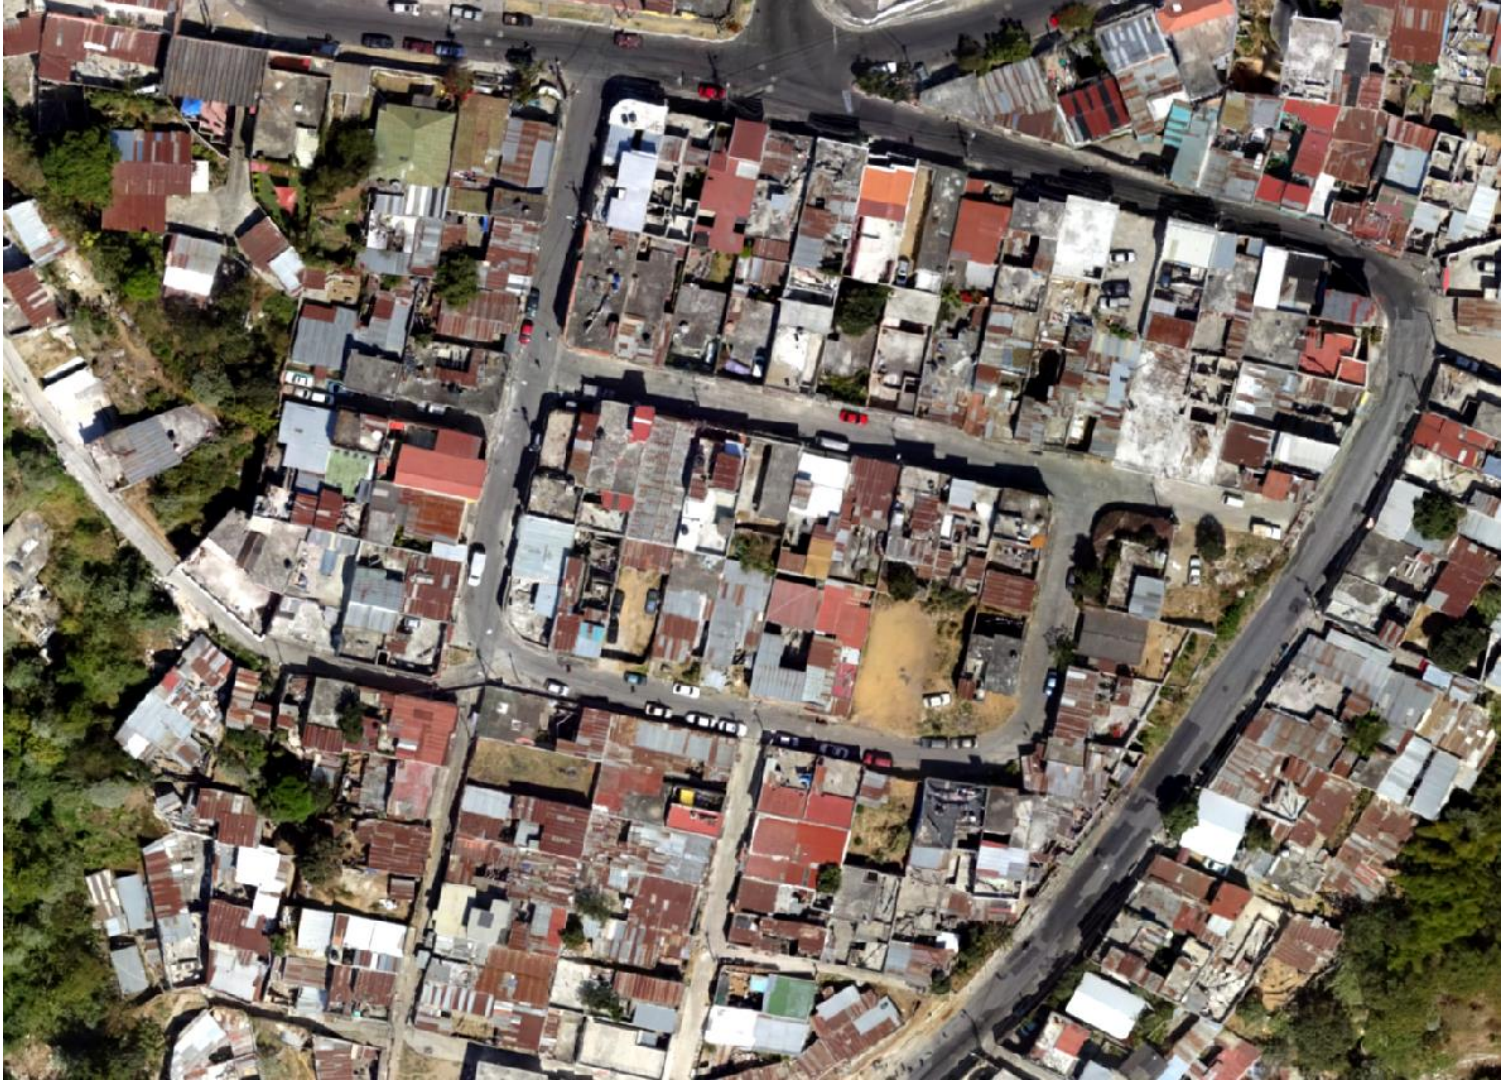
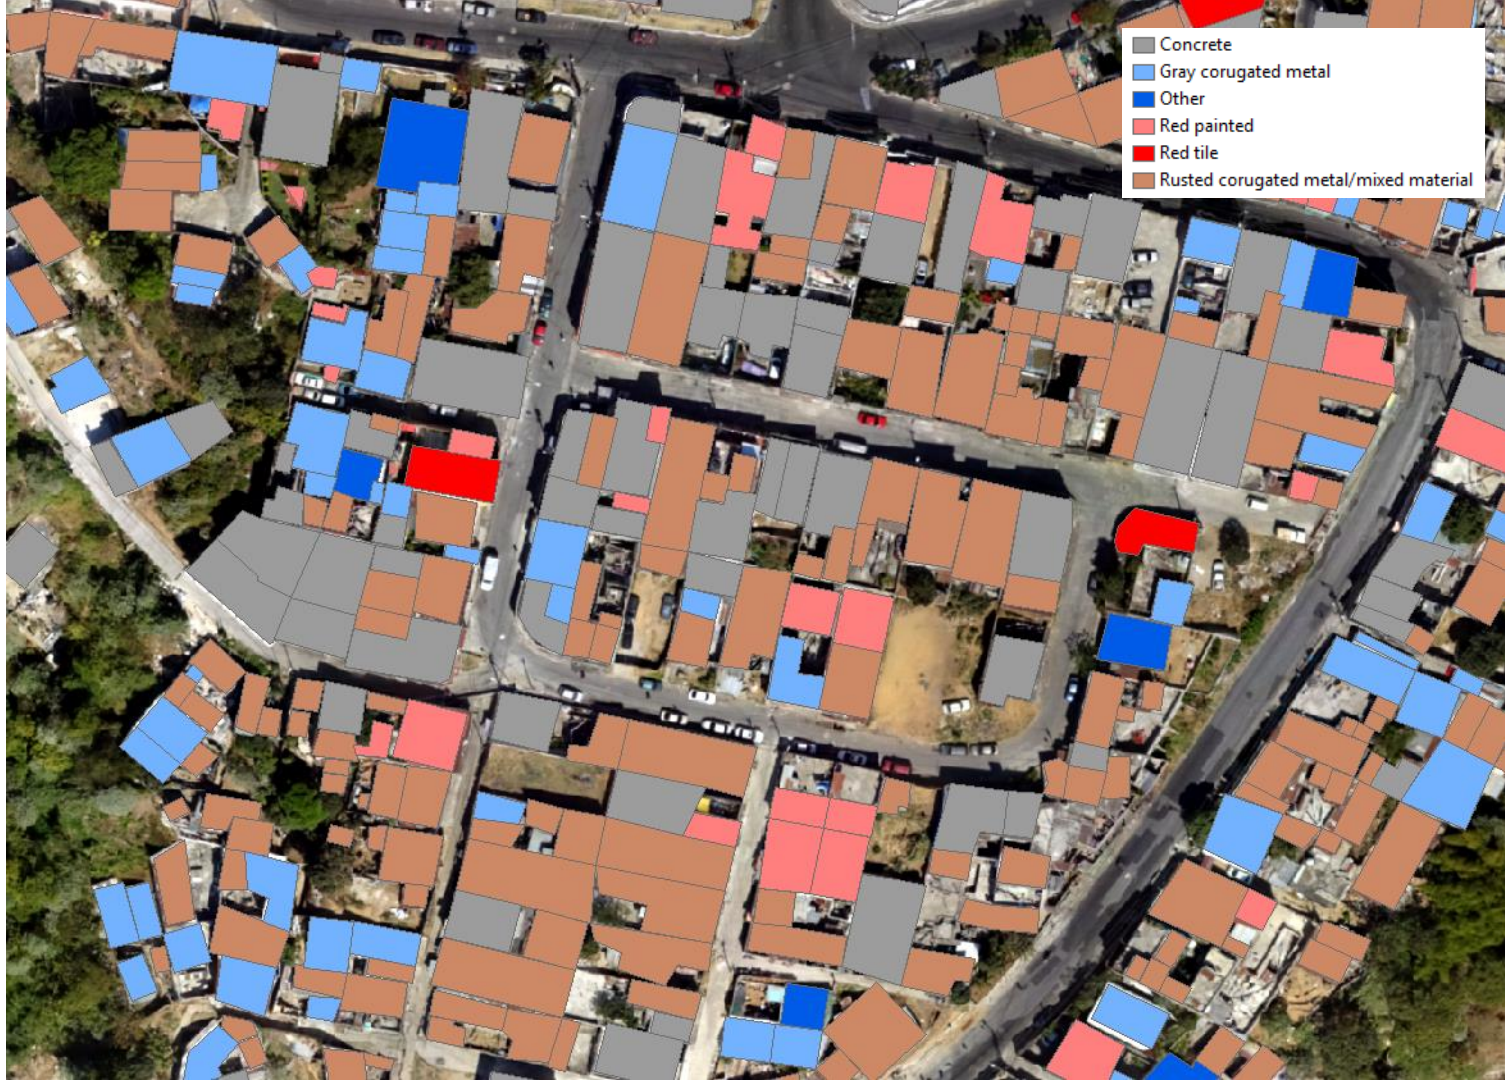
- Concrete
- Gray corrugated metal
- Other
- Red painted
- Red tile
- Rusty corrugated metal/mixed material

Digital Surface Model
High : 38 meters
Low : 0 meters

Two story building

One story building

Tall trees

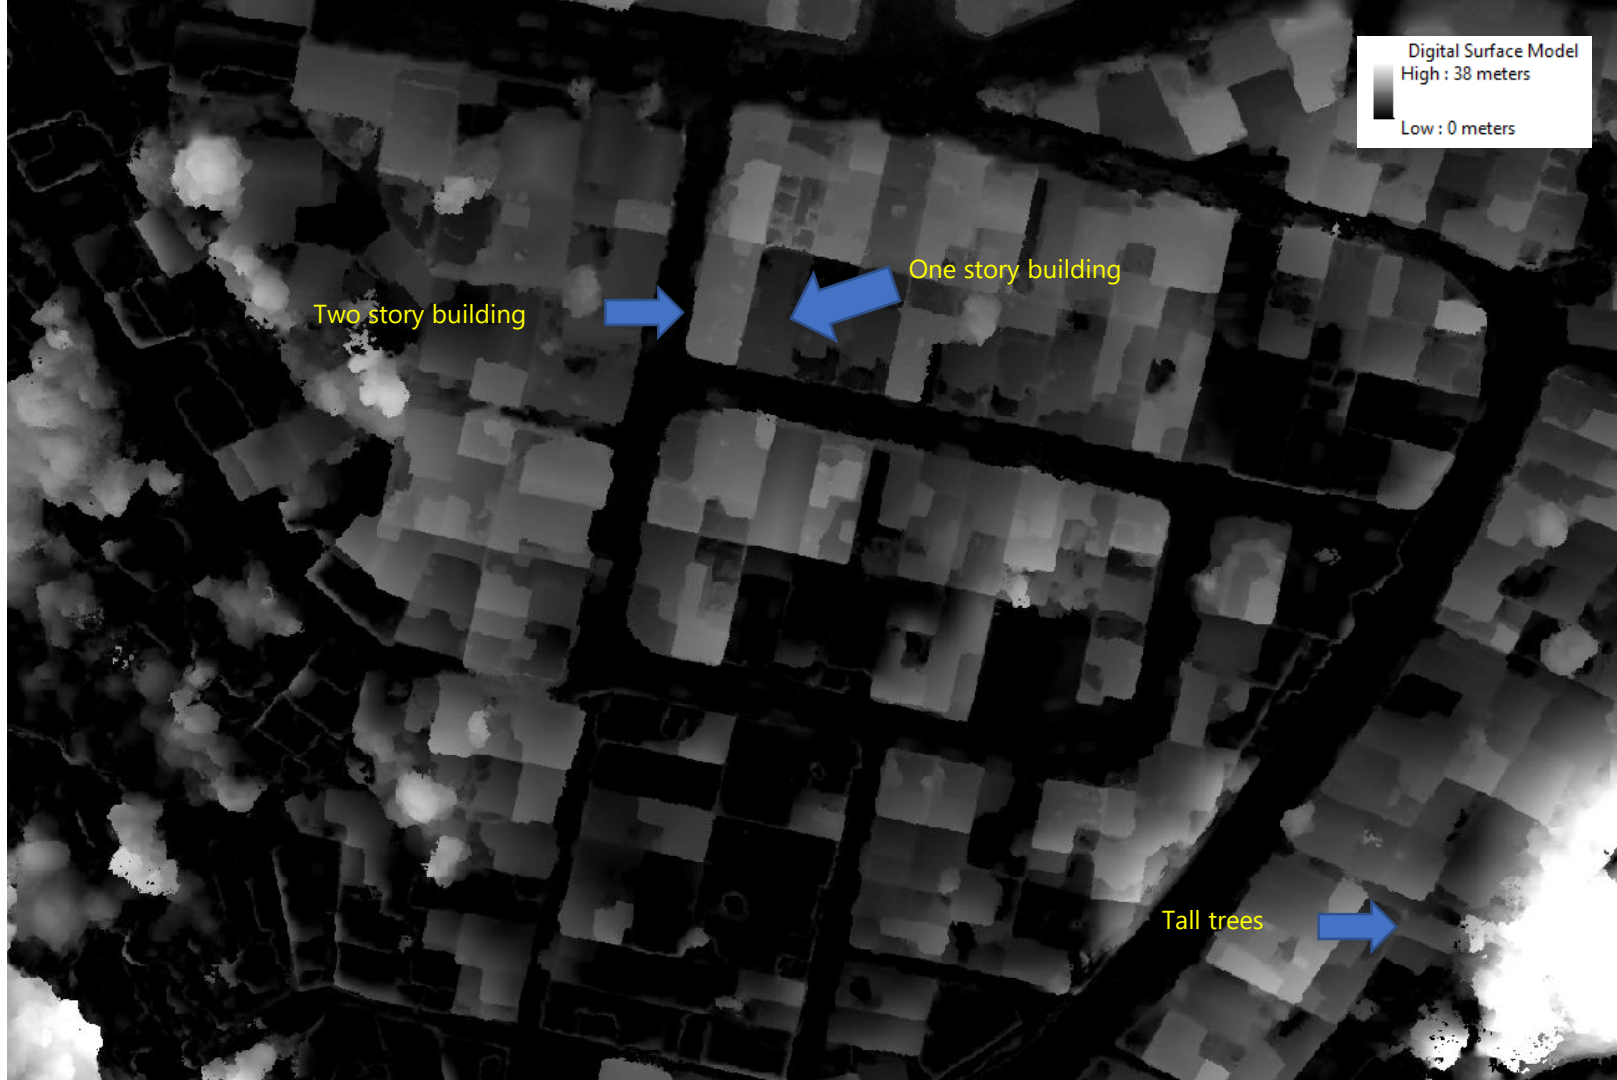
Calculate average pixel value (height) in each red polygon

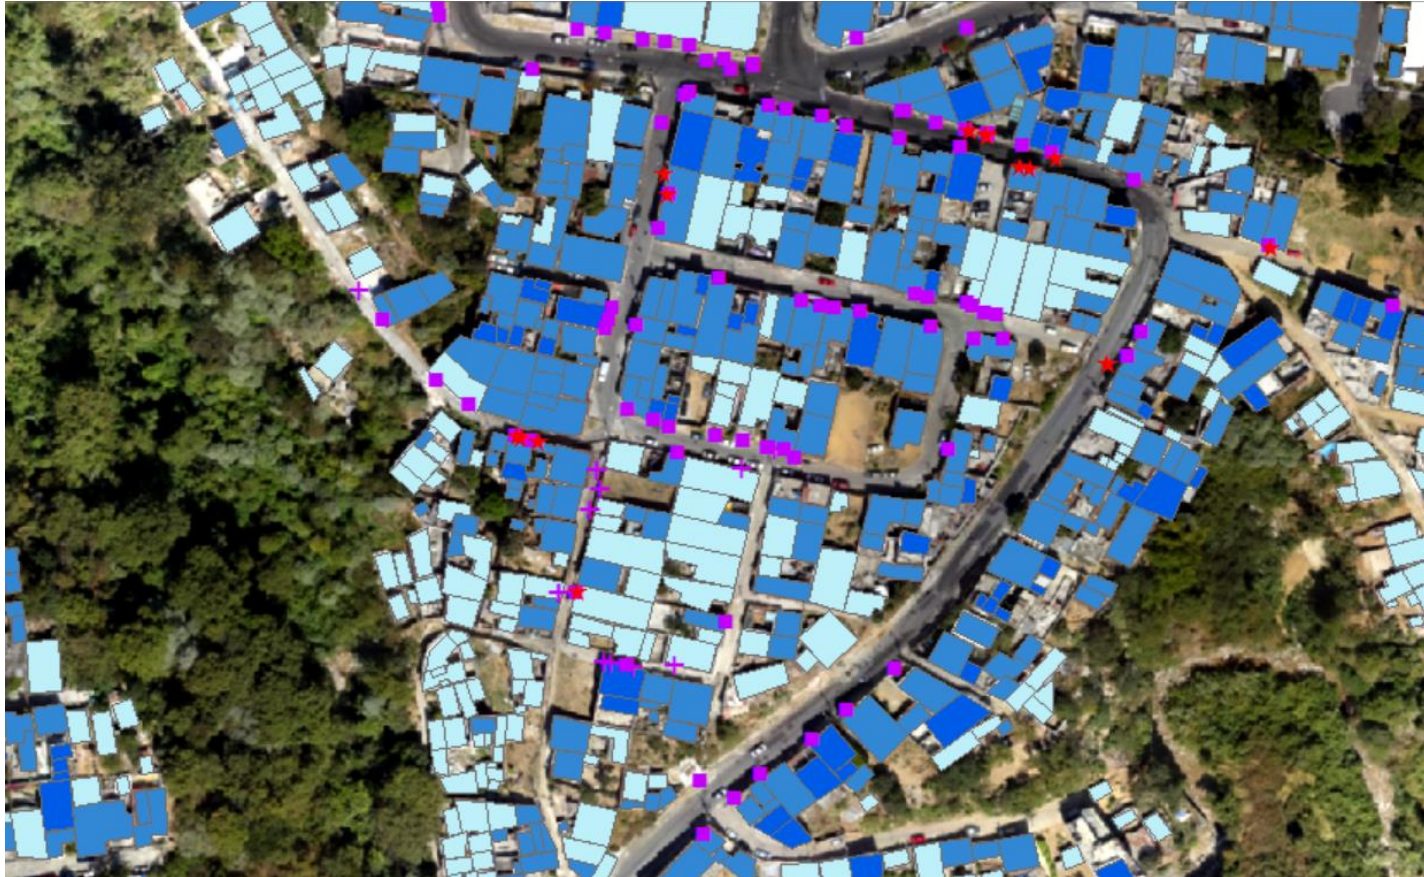
Combine data from the drone with data from the street...

Drone images..

- Single Story
- Two Story
- > Two Stories

Street images.

- Logos/Signs
- Garage
- Large Window

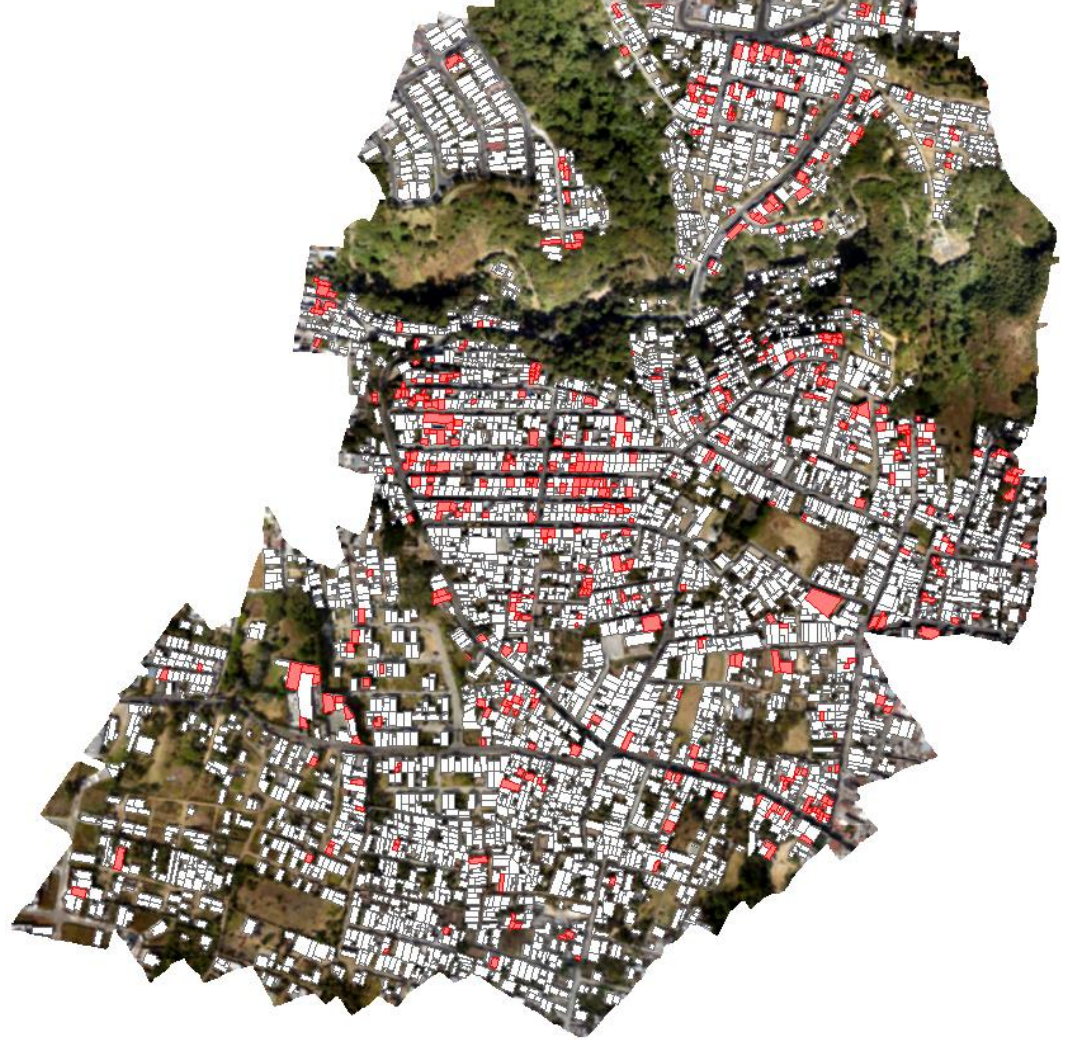
Possible Soft Story

Structures that are

- At least two stories high
- unconfined rooftops (corrugated metal)
- Built on a slope steeper less than 15 degrees

In this 100 hectares, there are 4,955 buildings - 503 of which should be evaluated for earthquake retrofitting

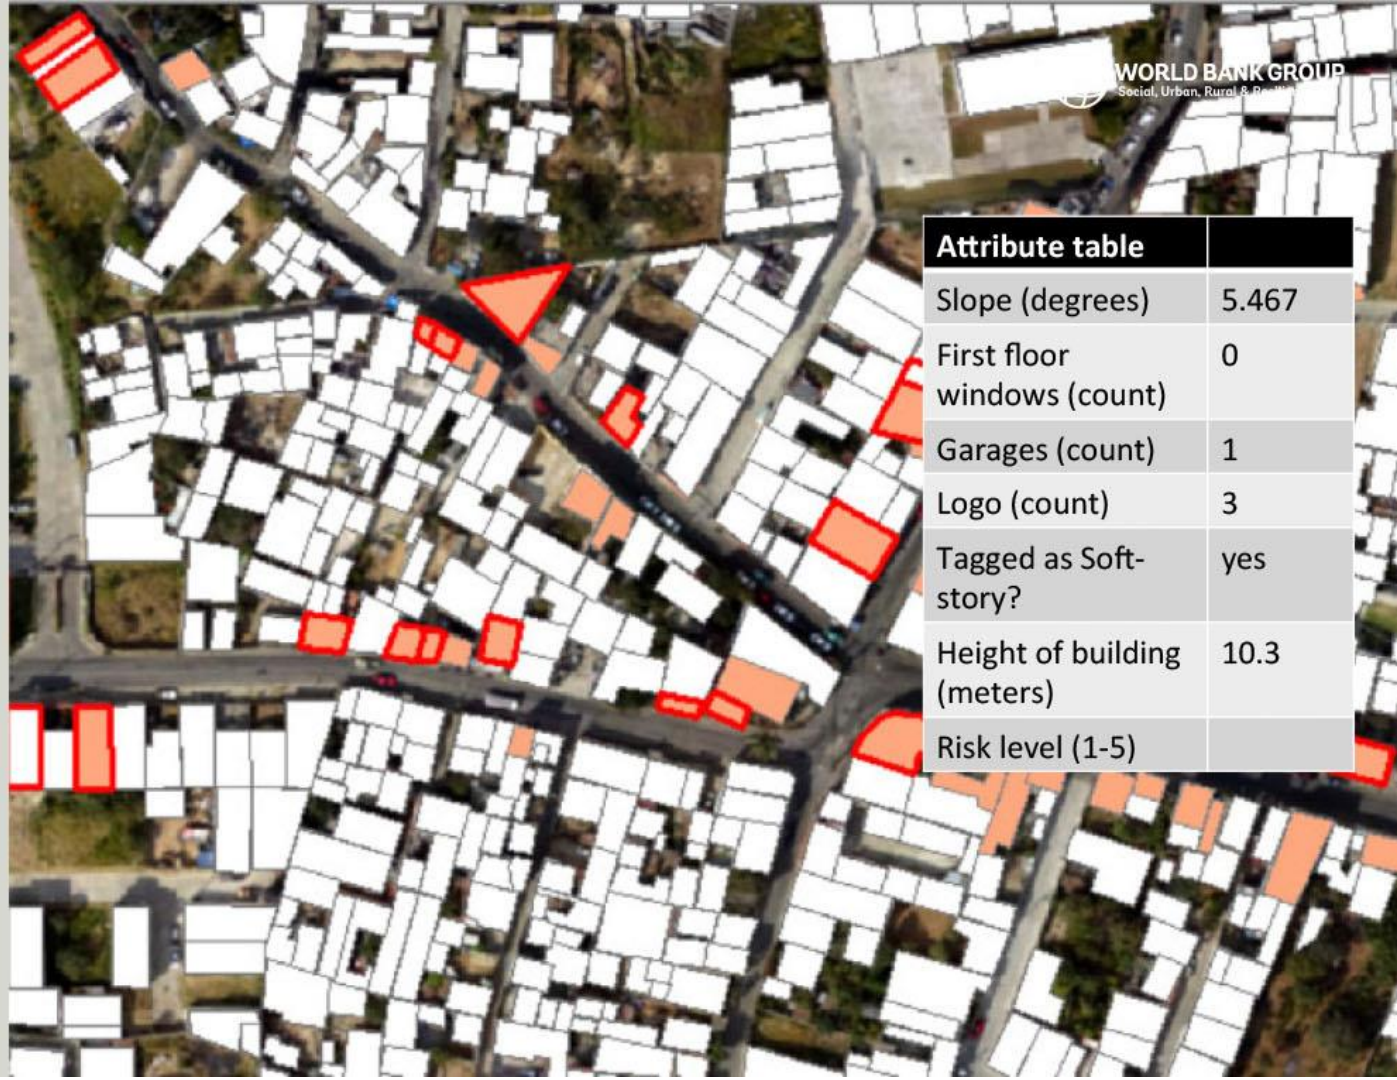
THE RESULTS

For each building we have the following characteristics –the thresholds picked are up to the decision maker/expert.

Attribute table	
Slope (degrees)	5.467
First floor windows (count)	0
Garages (count)	1
Logo (count)	3
Tagged as Soft-story?	yes
Height of building (meters)	10.3
Risk level (1-5)
