FIREFIGHTER FATALITY INVESTIGATIVE REPORT

**Sofa Super Store
1807 Savannah Highway
Charleston, South Carolina**

June 18, 2007

**City of Charleston
Post Incident Assessment and Review Team
Phase II Report**

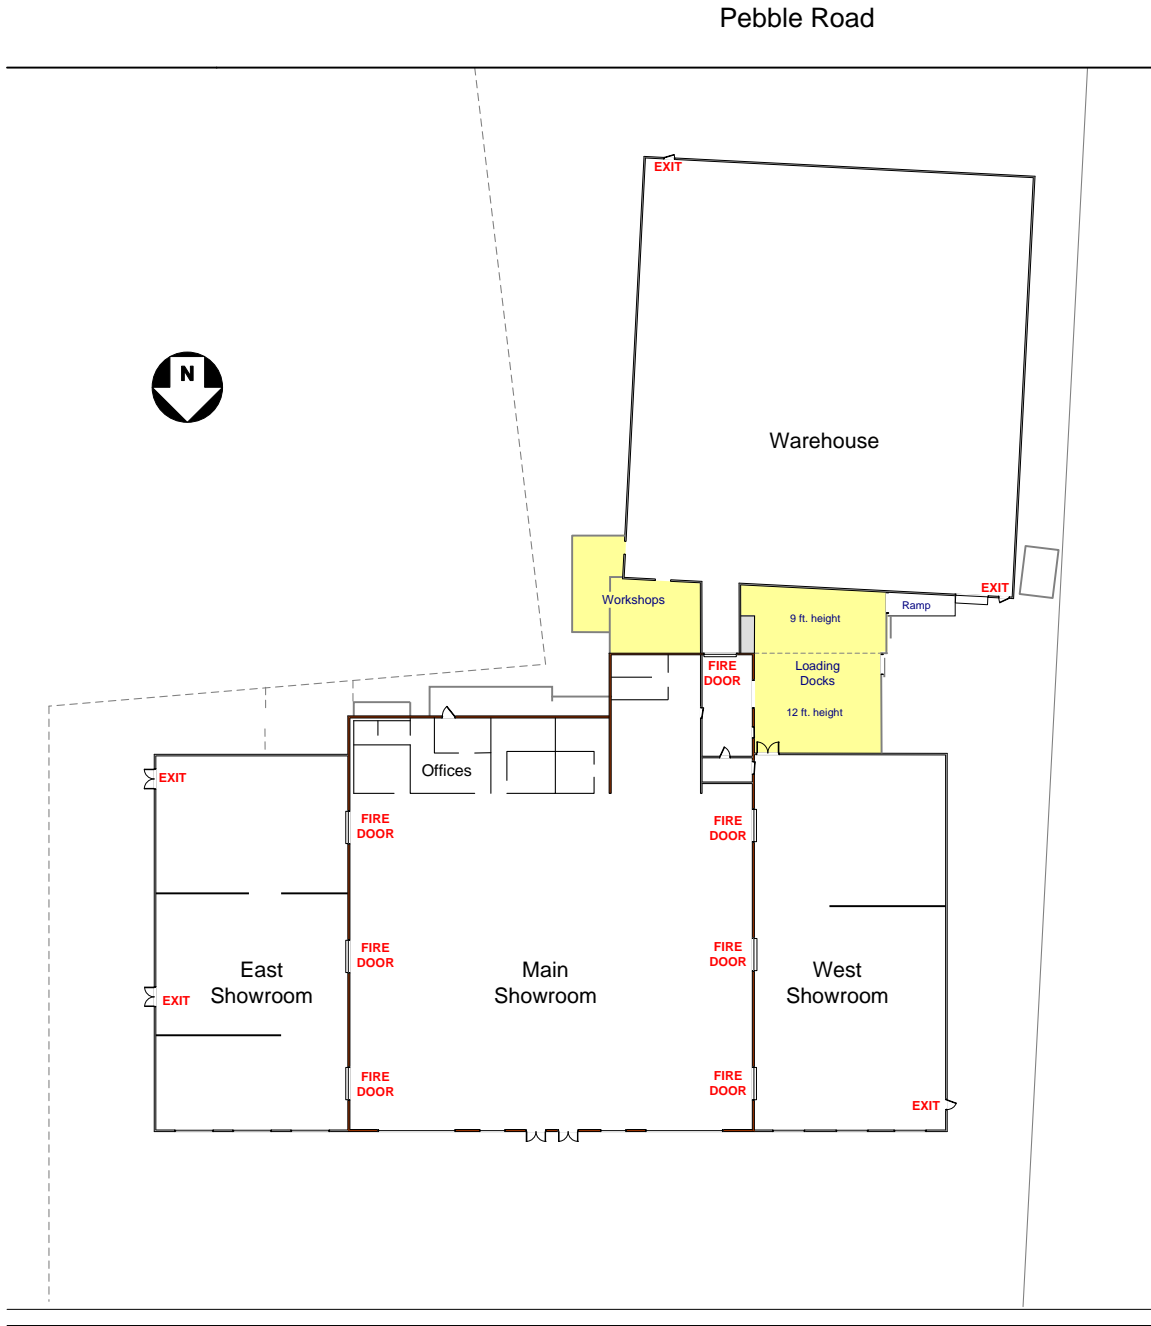
A small courtyard, approximately 15 feet wide and 5 feet deep, was located between the east wall of the loading dock and the west wall of the passageway leading to the warehouse. Several air conditioning units were located in this space that was accessed by a doorway at the east end of the loading dock.

Figure 3: The space between the warehouse and the showrooms was filled-in with the construction of the loading docks and workshops. Interior partitions were constructed to create offices and other spaces at the rear of the main showroom.

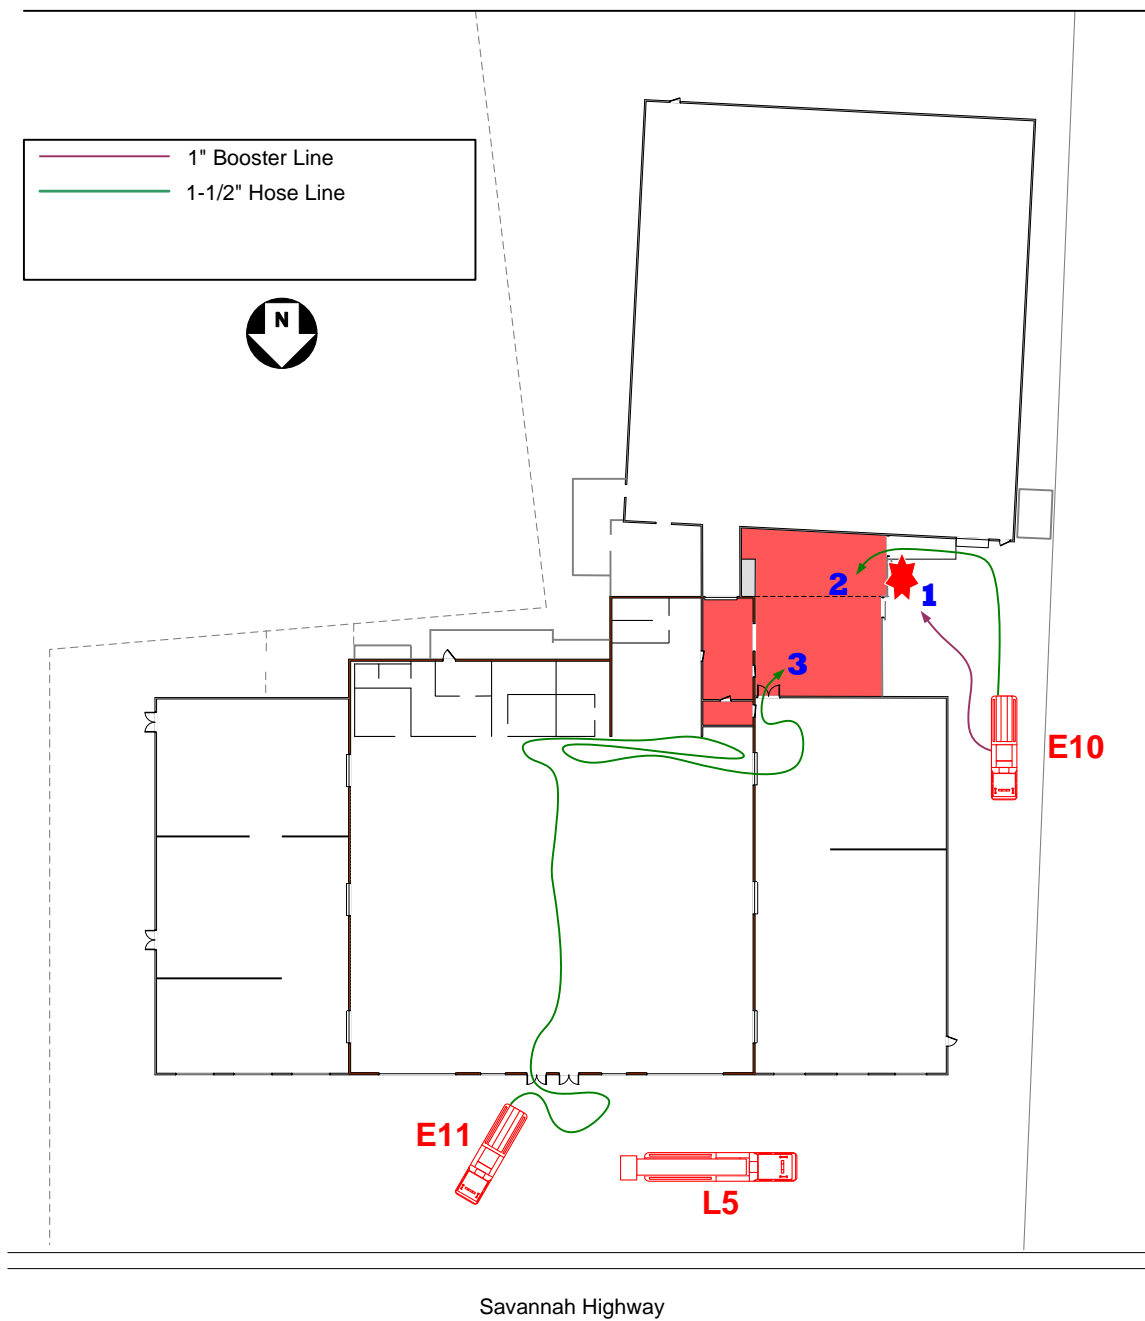
Figure 10: Initial attack hose lines in operation. (Approximate time 19:16)

- 1: 1" booster line from Engine 10 attacking exterior fire.
 - 2: 1-1/2" preconnect from Engine 10 advanced into the loading dock
 - 3: 1-1/2" preconnect from Engine 11 advanced by Ladder 5 crew through the showrooms to the double doors and into the loading dock.
- The fire has extended across the loading dock and into the holding room.

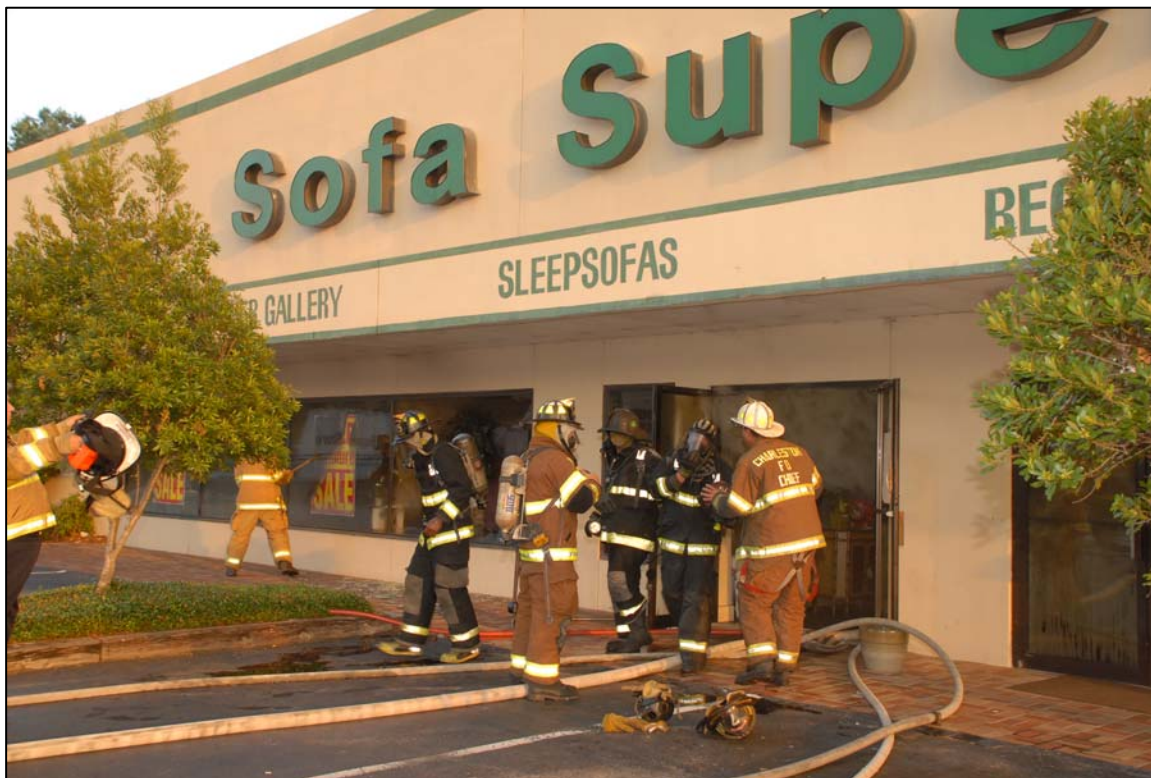
Photo 5: The crew of Engine 6 and Engine 15 emerge from the structure. Battalion Chief 5 is breaking a window in the background. This photo was taken at 19:35:14. (Photo courtesy Bill Murton, Charleston Police Department)

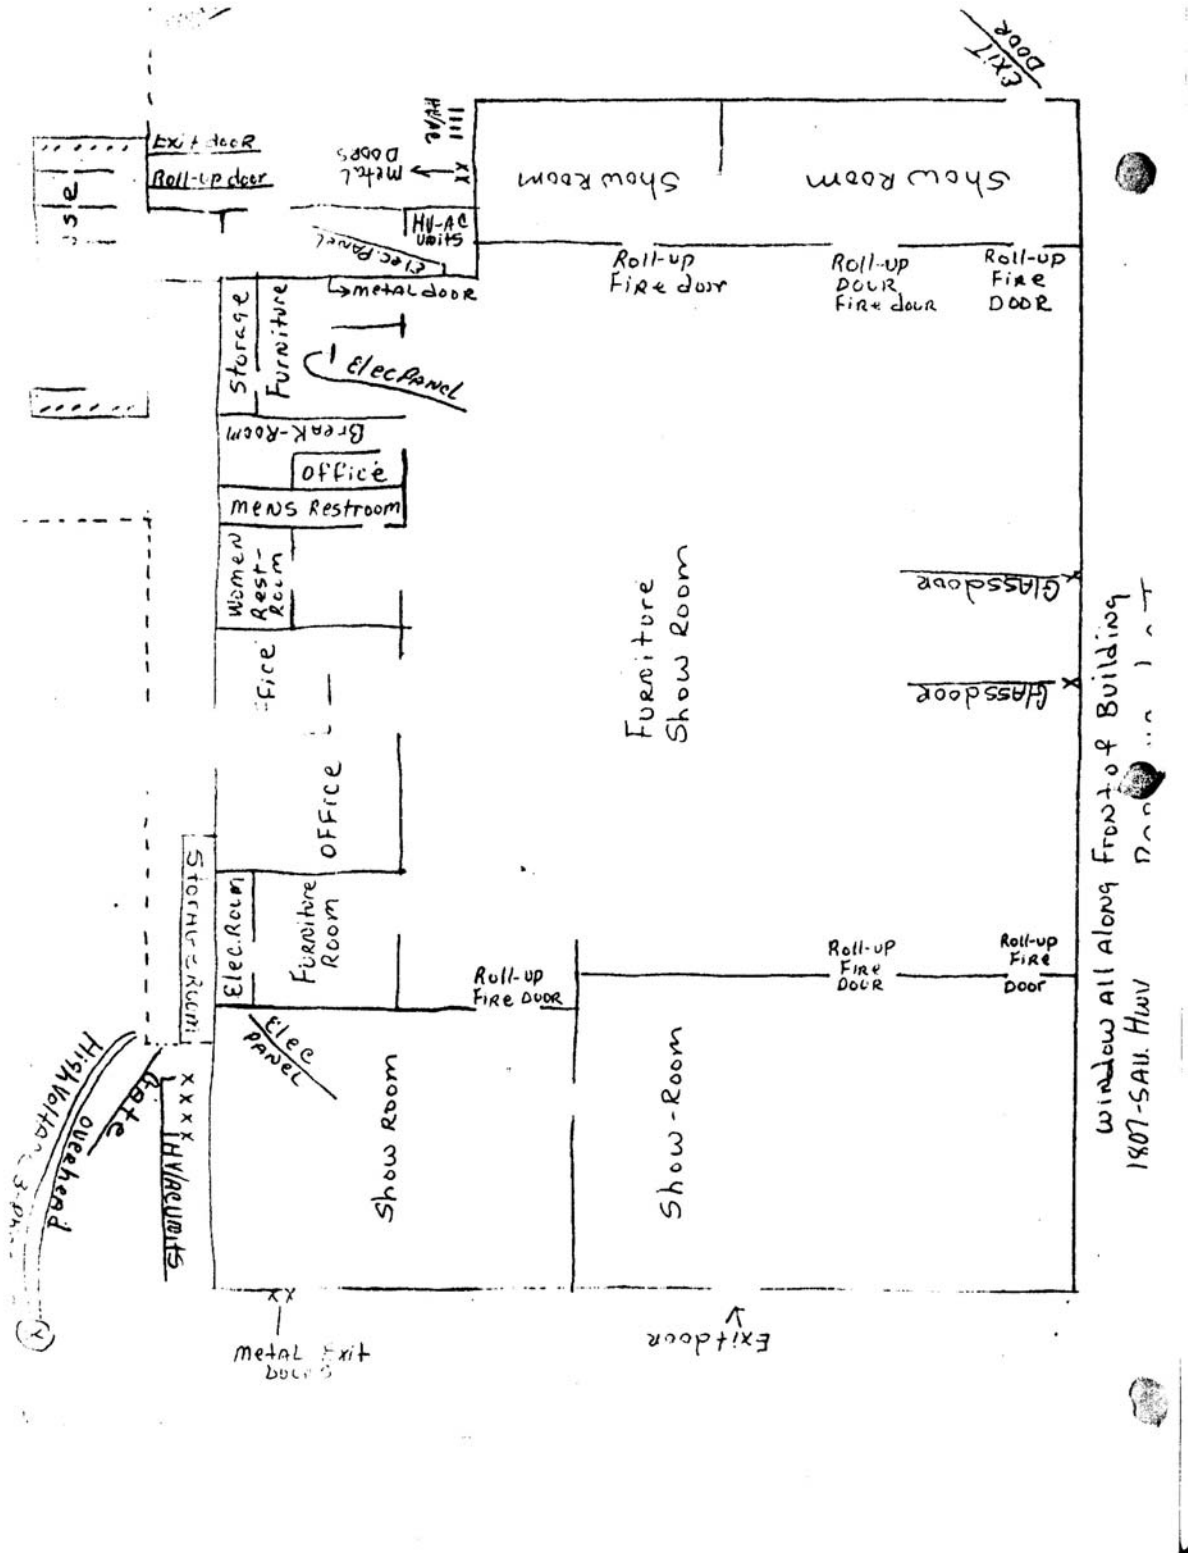
Figure 17: Pre-fire plan sketch.

The Charleston Fire Department members assigned to the incident had varying degrees of familiarity with the Sofa Super Store. Most of the firefighters who were assigned to companies in the West Ashley area were generally familiar with the Sofa Super Store and recognized the potential for a major fire at that location. In addition to conducting pre-fire planning visits, several of the firefighters had shopped in the store; others had picked-up discarded furniture from the area where the fire originated for use in training exercises.
