## Memorandum

From: ICC/ANSI A117 Editorial Task Group

Re: Inconsistency Questions in 2015 A117.1 Draft

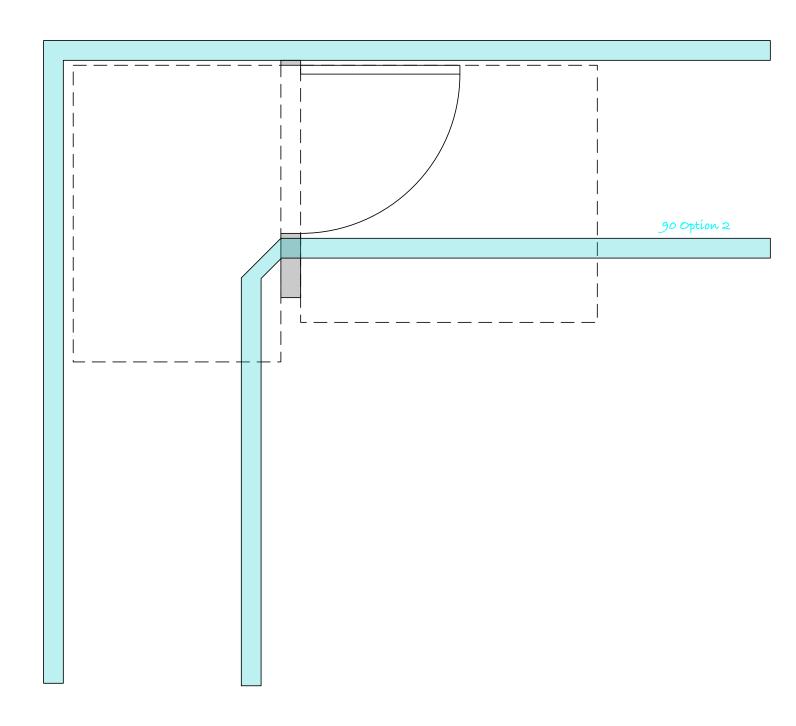
## Illustration 2 This illustrates the conflict between Items 2a, 2b and 2d of Editorial Task Group 4/5/16 Inconsistency Questions Memo

Example of the problem: The 32" narrowing is allowed at doorways along a 36" route. If there is a turn into a door or doorway, the 90 degree turn does not have an allowance for the reduction to 32" until you get past the turn and back to the 36" route. In turns where there is no limit on the depth of the turn (See Illustrations 1 and 2), how far back does the door have to be from the turn? Is it allowed on turns that have a cut back corner?

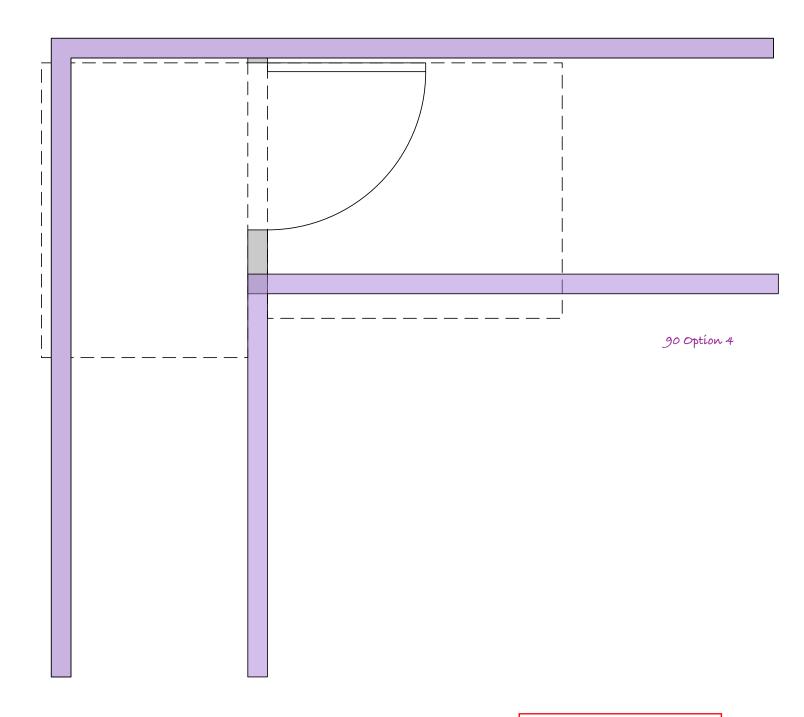
Illustration 4
This illustrates the conflict between Items **2a and 2b** of Editorial Task Group 4/5/16 Inconsistency Questions Memo

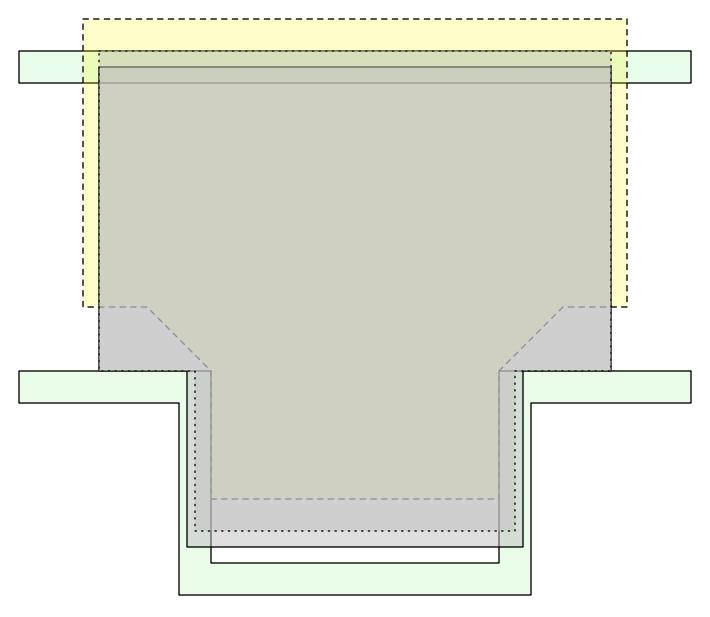
Alcove and T-turns

Illustration 6
This illustrates the conflict between Items 2a and 2c of Editorial Task Group 4/5/16 Inconsistency Questions Memo

- 3. In addition, the allowance at Section 304.3.2.1 for knee and toe clearance at a turning space is inconsistent with the alcove provisions in Section 305.7. (See Illustrations 6-10) For instance, the text fails to establish whether the chamfered area belongs to an arm or base of the "T" or to both? The result is that we cannot determine how much, if any, of the chamfered area can be overhung by an object permitted to overhang one arm or the base.

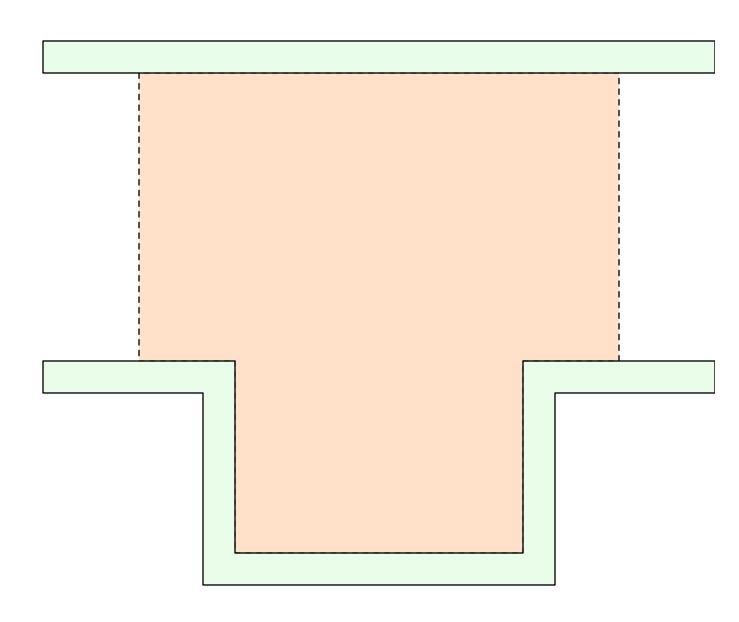
Illustration 7
This illustrates the existing criteria in the 2009 Standard

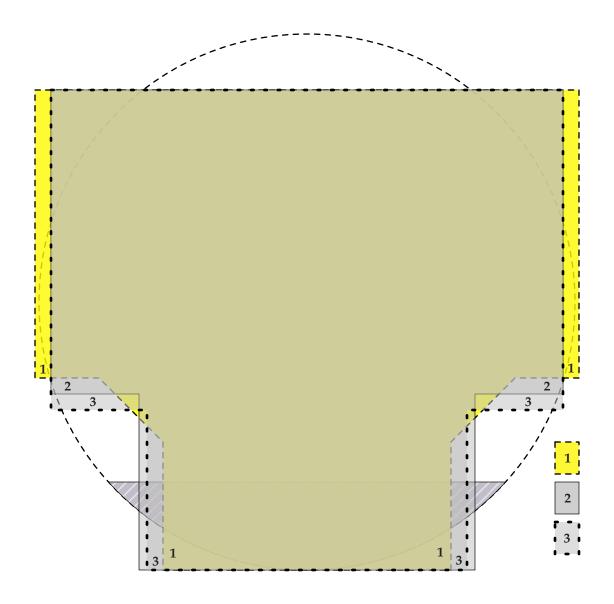
Base overlap of turns

Illustration 8
This illustrates the conflict in Item **2a** of the Editorial Task Group 4/5/16
Inconsistency Questions Memo

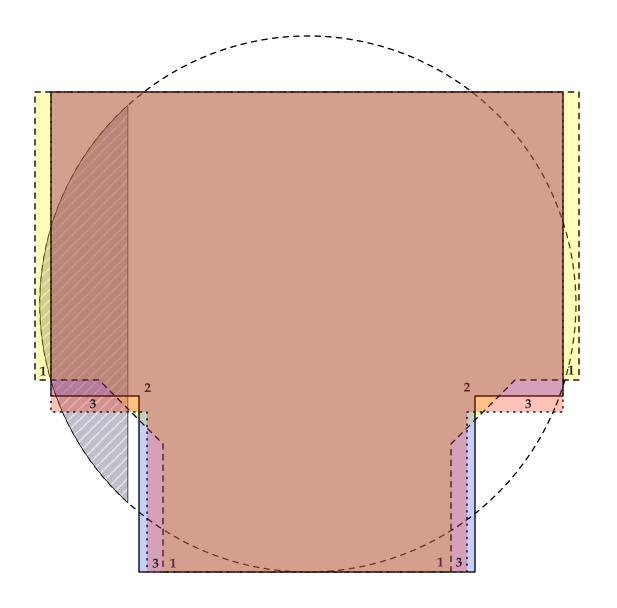
Arm overlap of turning spaces

Illustration 9
This illustrates the conflict
between Items 2a and 3 of
Editorial Task Group 4/5/16
Inconsistency Questions
Memo

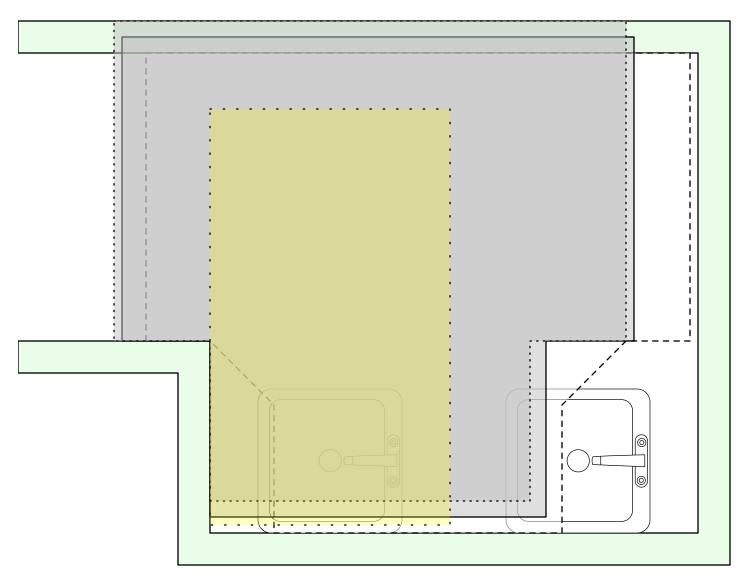
Double drinking fountain and T-turn

Illustration 10
This illustrates the conflict
between Items 2a, 2c and
3 of the Editorial Task
Group 4/5/16 Inconsistency
Questions Memo
