# Public Comments Received by NIST on Draft Reports:

Technical Study of the Sofa Super Store Fire - South Carolina, June 18, 2007  
*Volumes I and II*  
DRAFTS FOR PUBLIC COMMENTS

October 2010

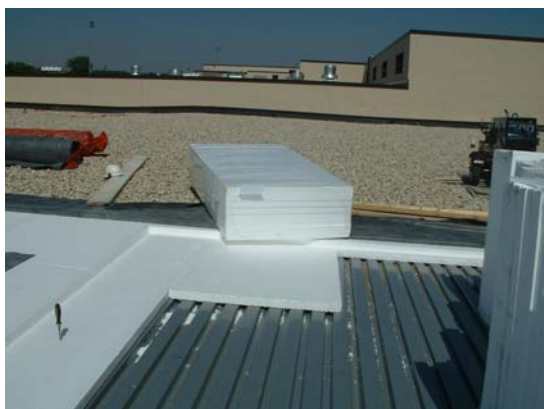
A potential problem with this type of roof was recognized more than 50 years ago: If a fire heated the underside of the roof deck, it could melt, vaporize, and ignite the asphalt on top of the deck, starting another fire in addition to the original one inside the building (see *Brannigan's Building Construction for the Fire Service* 4<sup>th</sup> Edition, 213-214). This roof fire could spread far ahead of the original fire and ignite other fires when burning asphalt found its way through the steel deck. You can identify this type of roof by the asphalt “icicles”

that often form along walls (photo 1) and at seams in the steel deck as a result of too much or too hot asphalt being used to assemble the roof. These “icicles” also form during and after a roof deck fire.

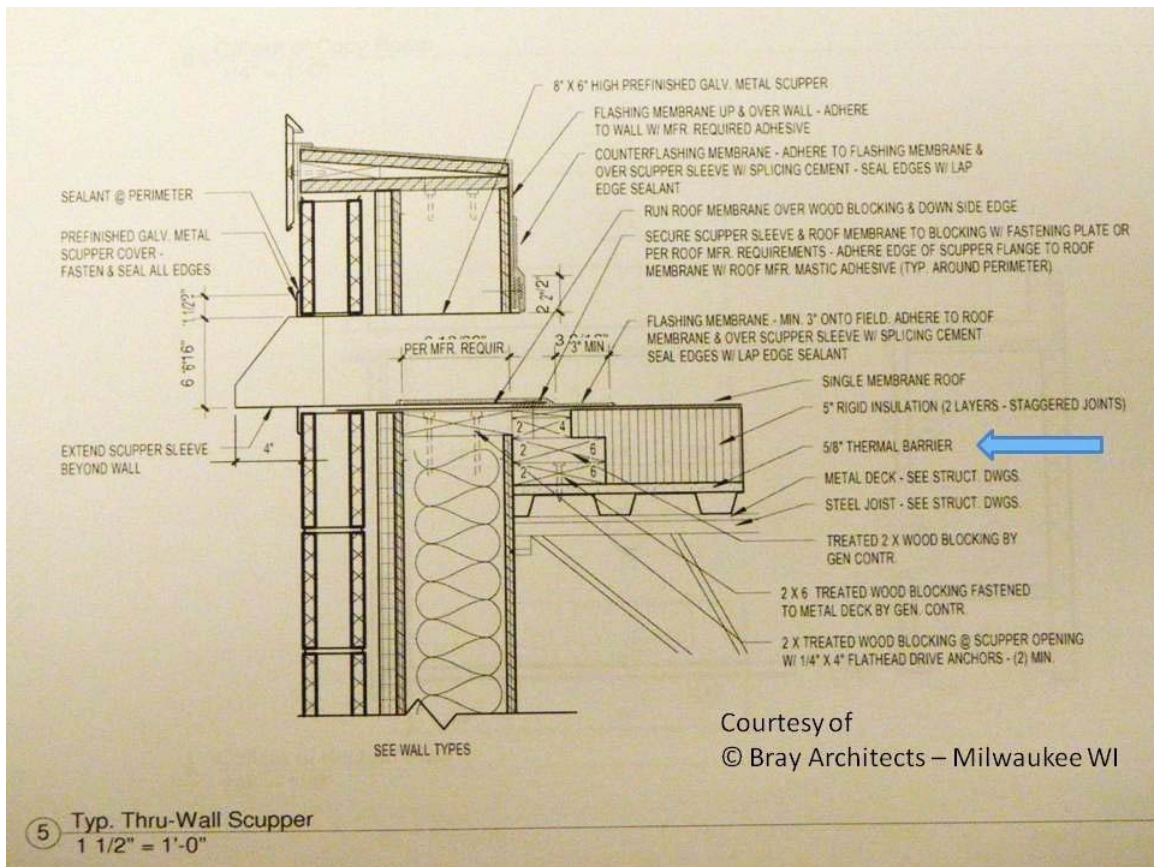
Photo 3 (*previous page*) shows a blueprint detail of the most recent development in metal deck roofs. A noncombustible thermal barrier (arrow) is laid down on top of the steel roof deck to separate it from the plastic foam insulation board. This thermal barrier provides enough separation between the steel deck and the foam insulation so that if there is a fire below the roof deck, it would be unlikely to start a second fire above the roof deck. The noncombustible thermal barrier is usually a moisture-resistant, fiberglass-faced, Type X gypsum board or a type of perlite board, ¼- to ¾-inch thick that meets standards like ASTM E-136 for noncombustibility and NFPA 255, *Standard Method of Test of Surface Burning Characteristics of Building Materials* 2006 edition (ASTM E-84 or UL 723) for low flame spread and smoke development. Search the Internet for “thermal barrier roof underlayment” and similar terms for more information from roofers’ associations and manufacturers.

Installing a thermal barrier between the steel deck and the plastic foam insulation on a modern roof is usually about five percent of the cost of the completed roof. However, building owners usually have tight budgets and often give up this fire-resistance feature so that their money can be spent where it will show. After all, the thermal barrier is of no value to the owner or to the business unless there is a fire, and most building owners don’t believe that this can happen to their building.

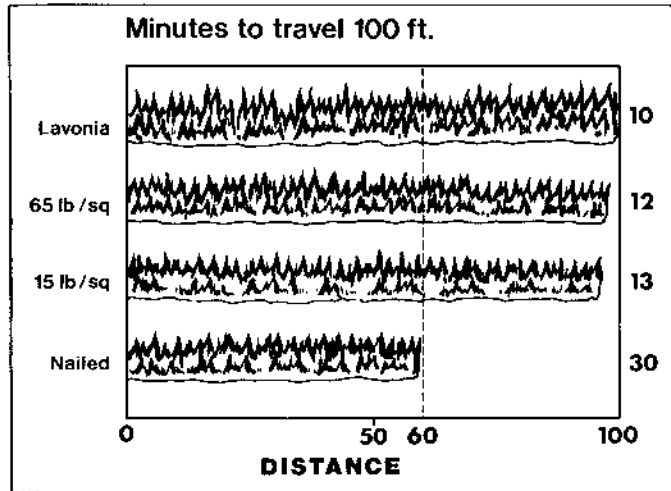
**ILLUSTRATION 2**  
Fire Spread in Large Scale Test Building

To establish criteria for fire-safe steel-deck built-up roof assemblies, Factory Mutual (FM) and Underwriters Laboratories (UL) built several large-scale building models to duplicate conditions that caused the intense burning and rapid flame spread in the GM fire. Incremental reductions were made from that level of combustibles until they were reduced to a safe level. The next step was to develop small-scale laboratory tests that duplicated the acceptable conditions determined by the large-scale tests.

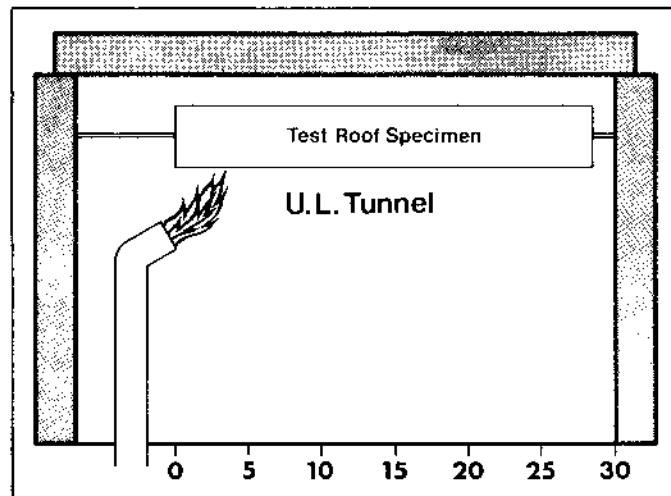
**ILLUSTRATION 4**  
Underwriters Laboratories Tunnel

UL took a different approach, featuring its already developed test device, the Steiner tunnel, which measures flame spread and smoke density of building materials in a 10-minute test using red oak as the basis for comparison. To fire-test steel deck roof assemblies, UL modified the Steiner tunnel and installed in it a metal deck system, with all components from deck through surfacing aggregate. By comparing results with the large-scale tests, UL determined that a satisfactory assembly would not spread flame more than 10 ft. down the tunnel in 10 minutes, 14 ft. or less in 30 minutes. The 100-plus different insulated steel deck constructions that have passed this widely accepted test are listed in the current edition of the *UL Building Materials Directory*.
