**NBSIR 81-2444**

# **Smoke Movement Through A Suspended Ceiling System**

Issued:  
February 1982

Final Report

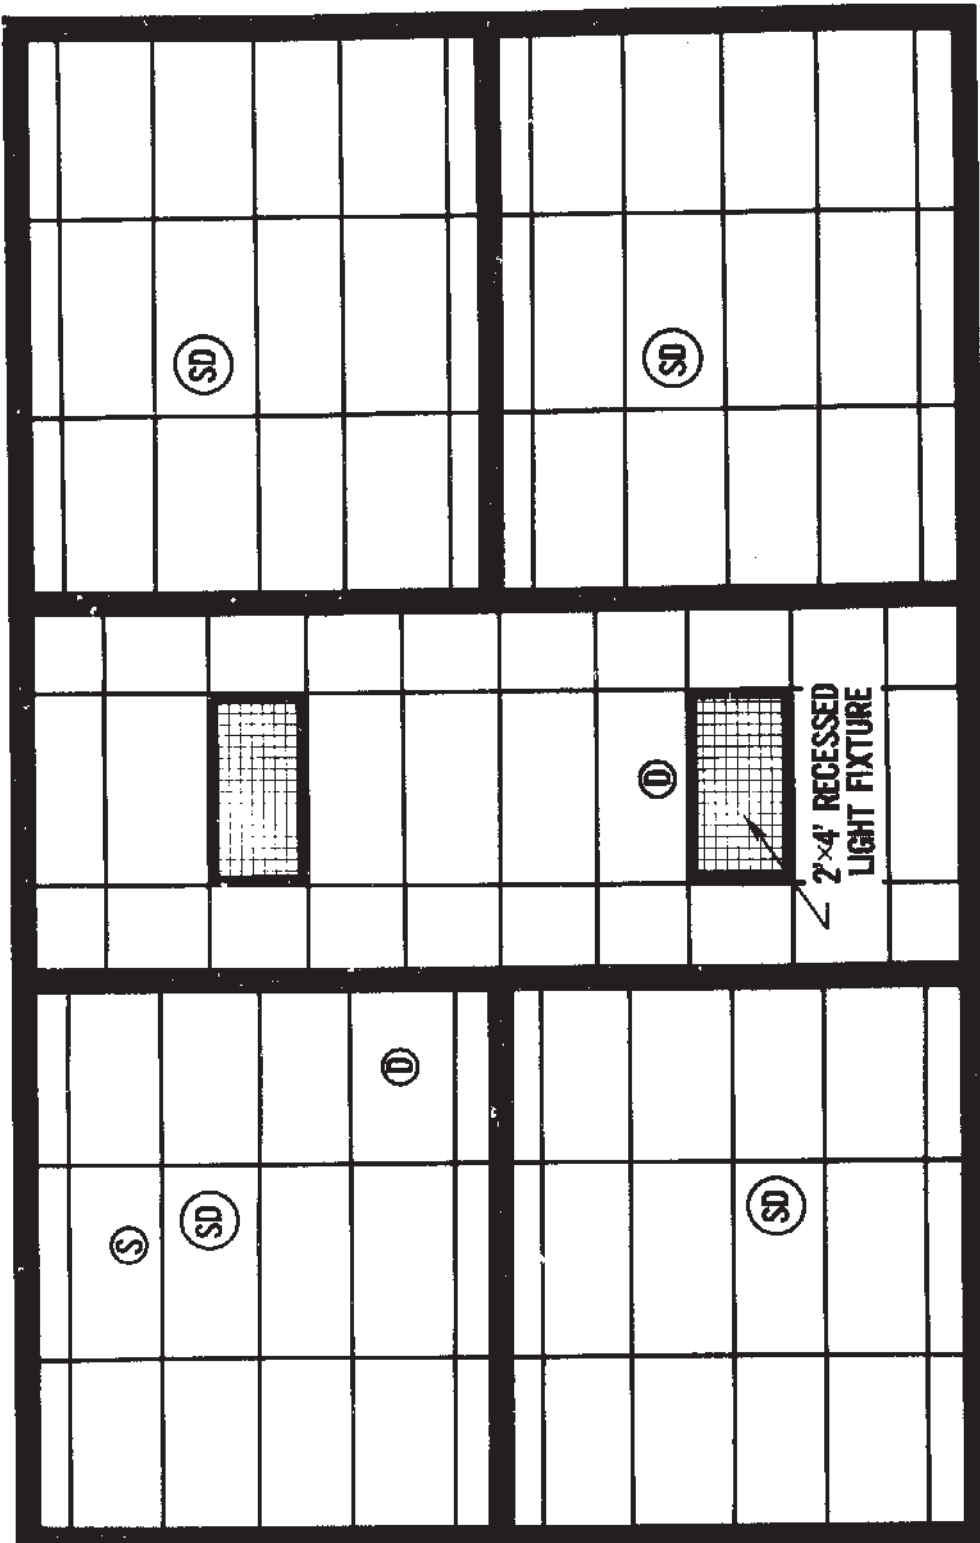
- Ⓢ TELL TAIL SPRINKLER
- Ⓣ SMOKE DETECTOR
- Ⓞ SUPPLY AIR DIFFUSER

Figure 3. Ceiling plan of test facility

Throughout this test series smoke detectors were located in the burn room and the corridor as shown in figure 3. Activation times for these detectors are listed in table 8. During the smoldering tests the corridor remained essentially smoke free and accordingly the corridor detector was not activated. It is well known that the activation time of ionization detectors is longer for smoke from smoldering fires than for flaming fires. The activation time during the three smoldering tests was in the range of 27 to 60 minutes which was considerably greater than the activation times during the flaming tests.

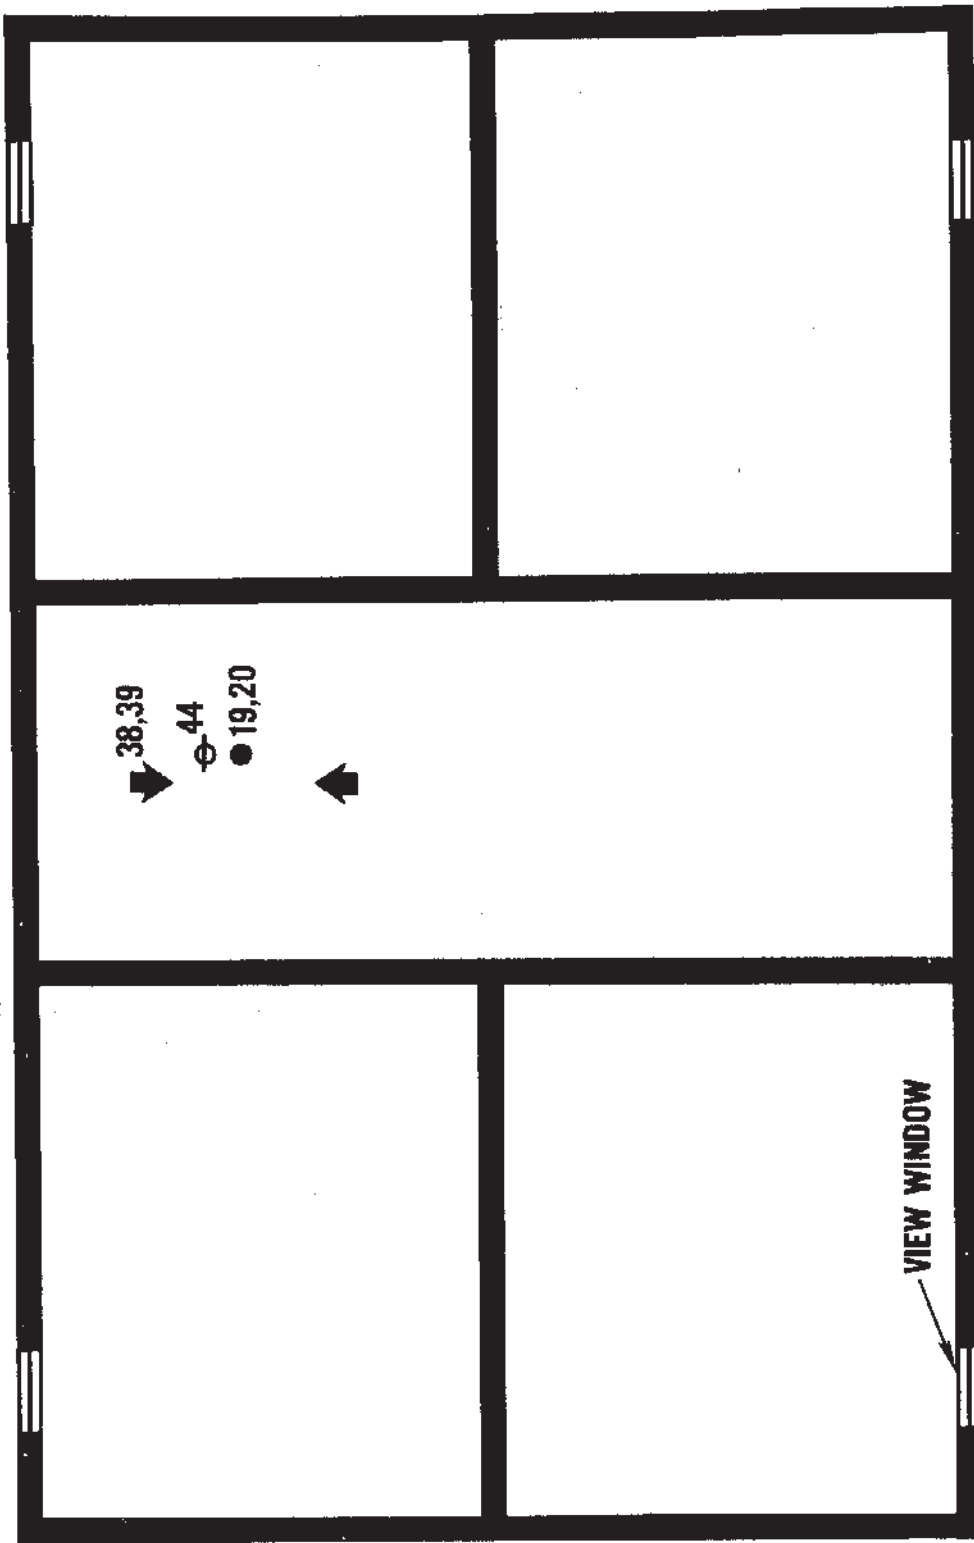
Figure 6. Instrumentation plan for interstitial space

The instruments used in this test series are shown in figures 5 thru 9 and are listed in table 2. Response times of smoke detectors and a tell-tale sprinkler were recorded automatically by activation of a relay which stopped a clock. All tests were recorded with 35 mm still camera or on video tape with separate coverage in the burn room and in the interstitial space. Generally, all instrumentation channels were recorded at 20 second intervals for the smoldering tests and at 13 second intervals for the flaming tests. The data acquisition system was located in an instrumentation trailer adjacent to the main building.
